## ***Crothers Environmental Group, LLC***

November 12, 2008

RE: Limited Asbestos Inspection – Stanley Hall  
Waterbury State Office Complex

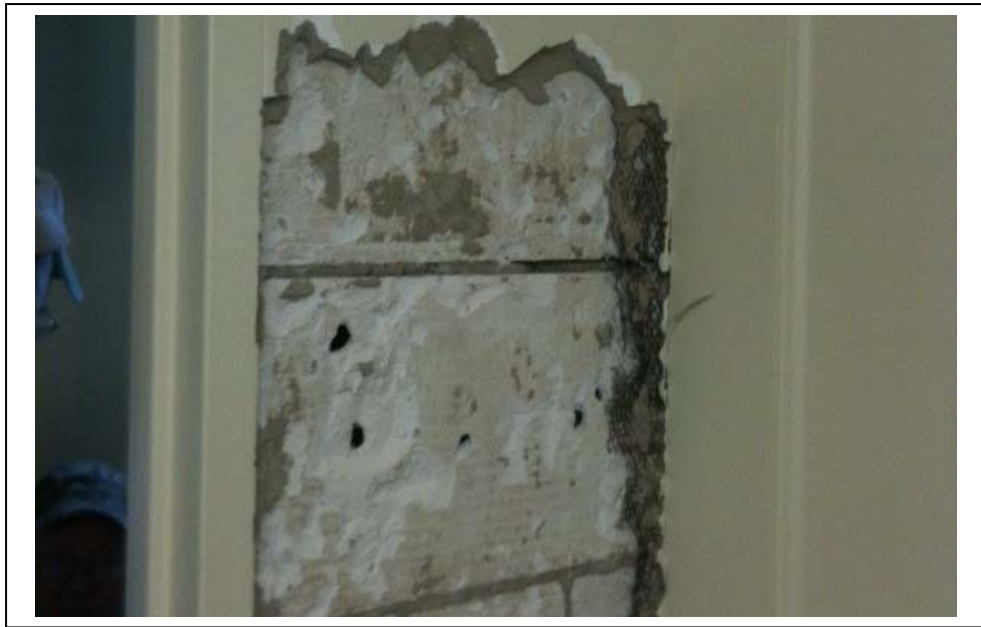
Per BGS's request we conducted a limited follow-up inspection for the presence of asbestos-containing materials at Stanley Hall in Waterbury, Vermont. This inspection was conducted on December 14, 2009. The general contractor demolished a wall and discovered suspect asbestos bricks and soft mortar that were not tested in the original inspection.

These materials were sampled and no asbestos was detected.
