**Waterbury Library / Municipal Complex**  
**28 North Main Street**  
**Waterbury, Vermont**  
KAS Project #505140338

**PHASE II ENVIRONMENTAL SITE ASSESSMENT**

June 26, 2014

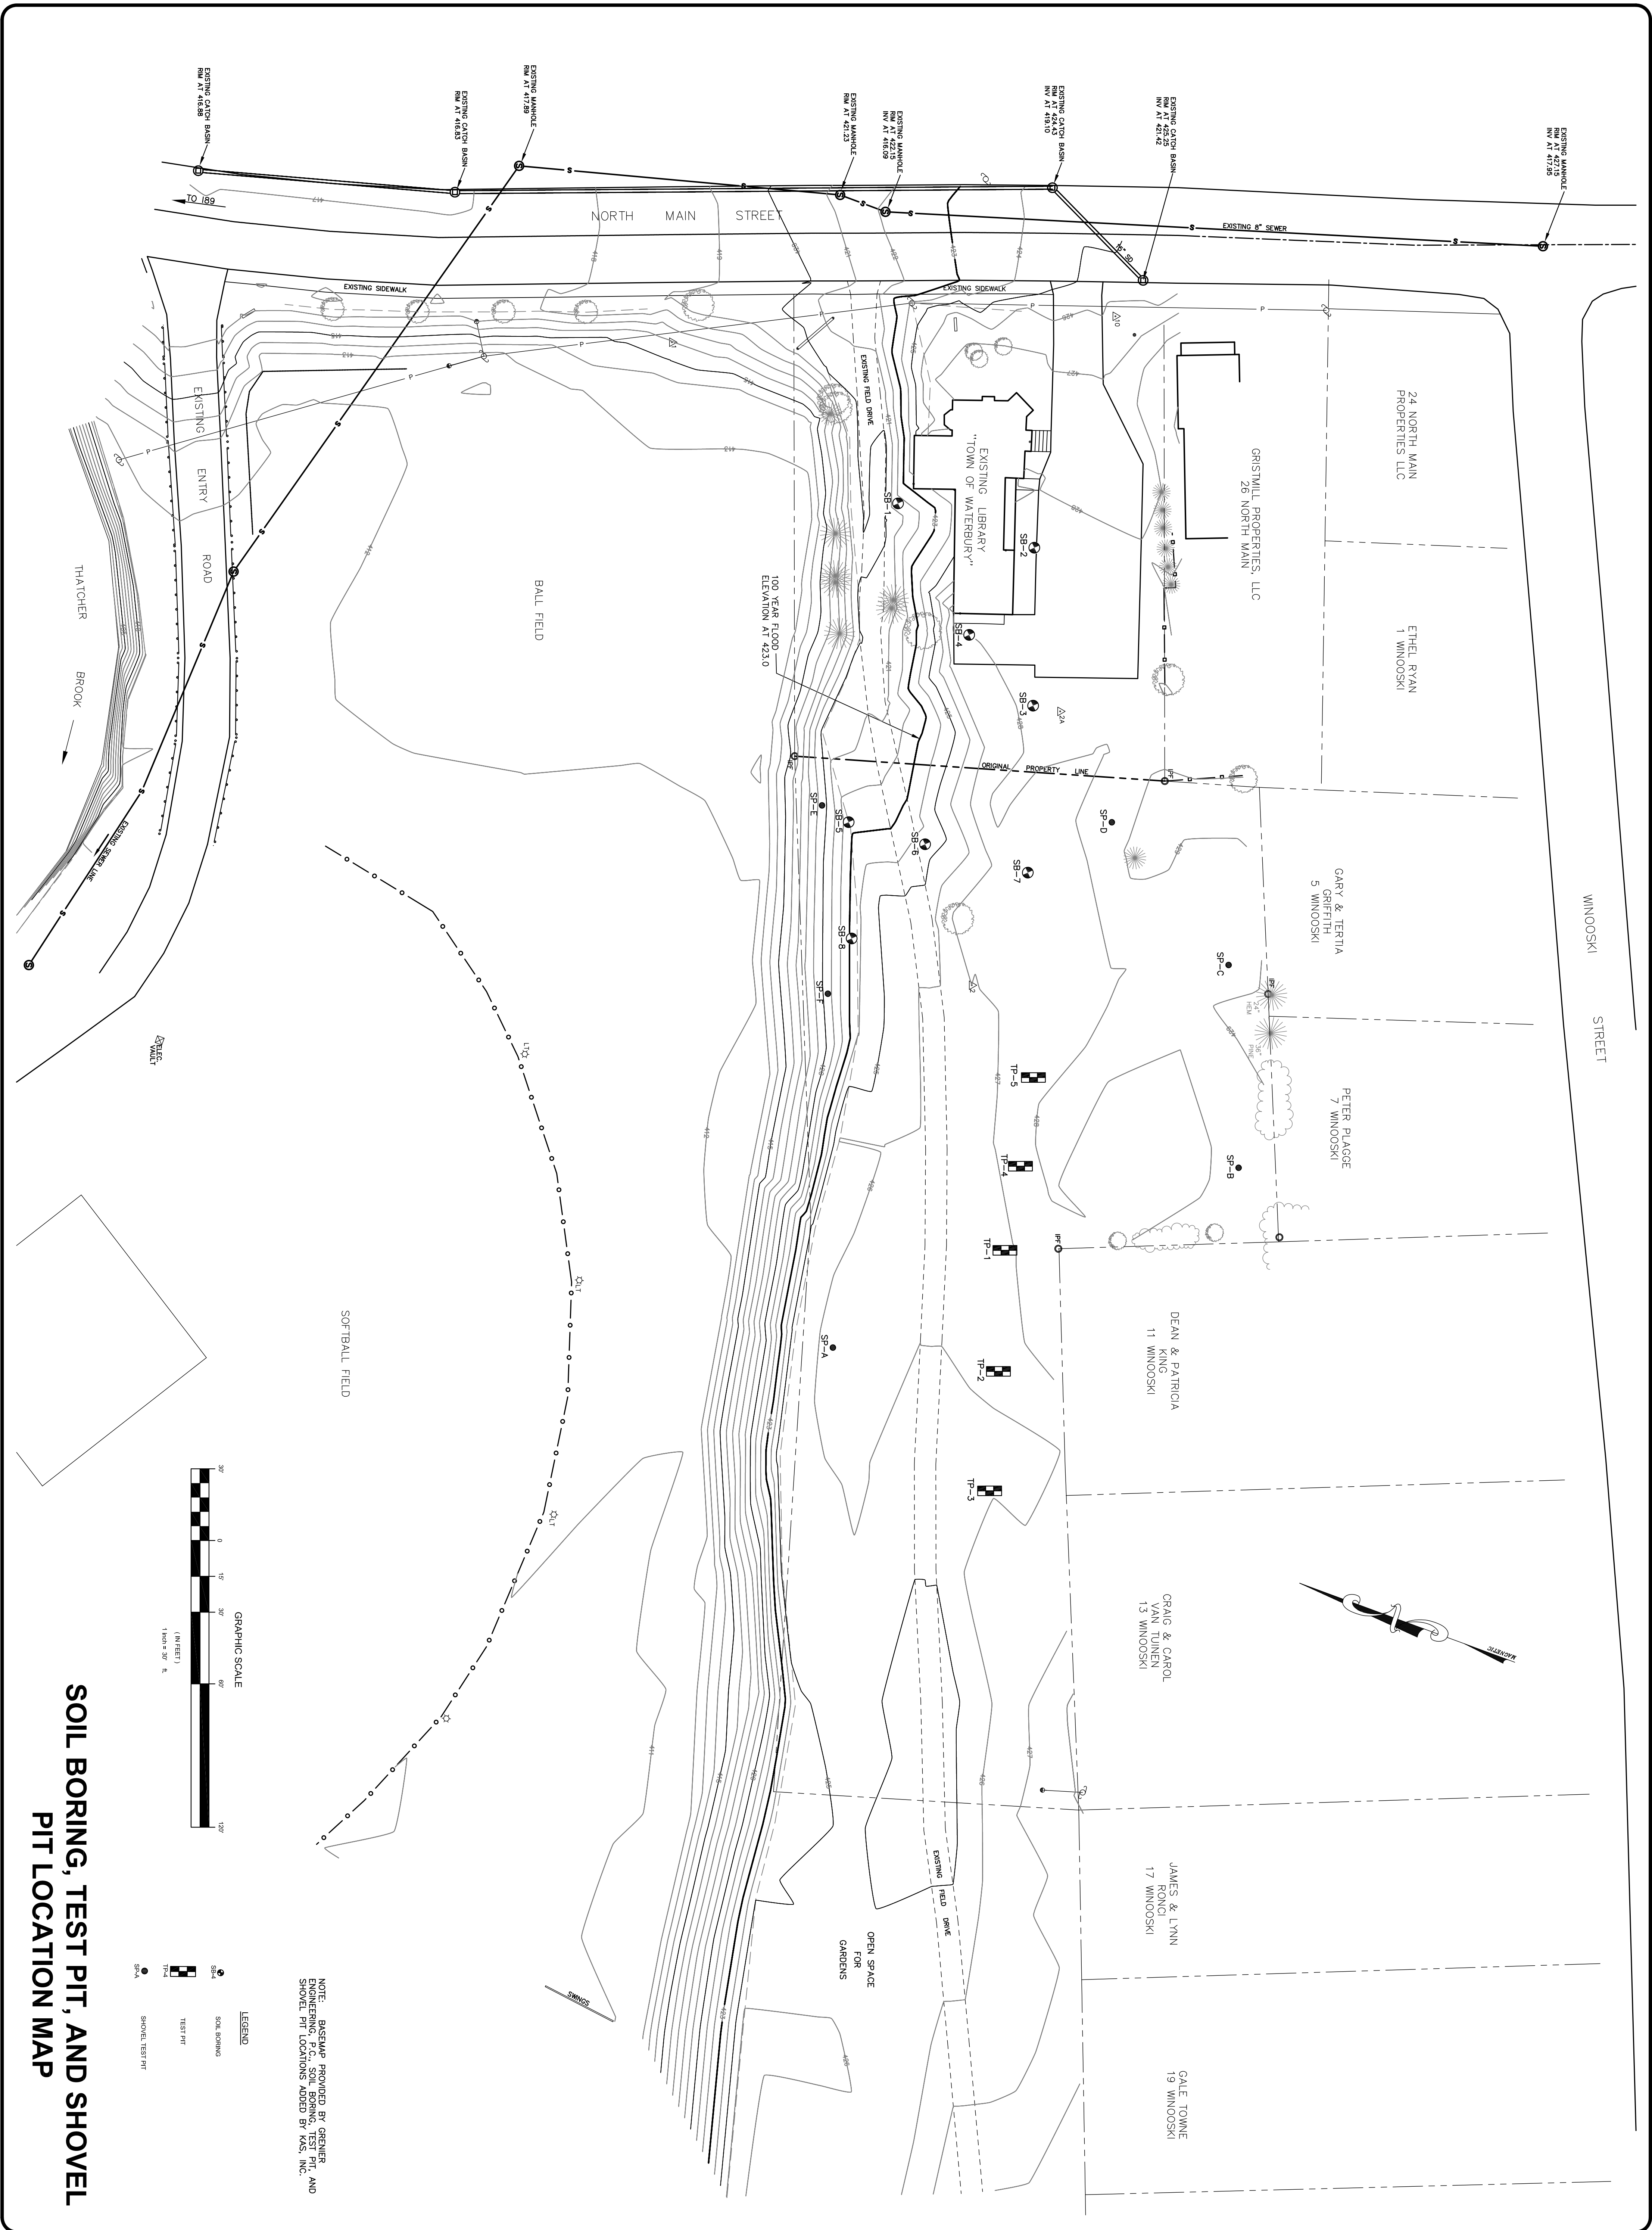
SOIL BORING, TEST PIT, AND SHOVEL PIT LOCATION MAP

Also on June 4, 2014, KAS completed six shovel test pits, SP-A to SP-F, to a maximum depth of 12-inches bsg. The purpose of the SPs was to distribute shallow soil sample locations throughout the site to the west of the existing building and parking lot and to target areas identified in the Hartgen Investigation that were described as "fill". All SBs, TPs, and SPs are shown on the Site Map in Appendix A.
