Colbyville Pedestrian/Bicycle Scoping Study

Final Report

Submitted by: Broadreach Planning & Design

June 15, 2017

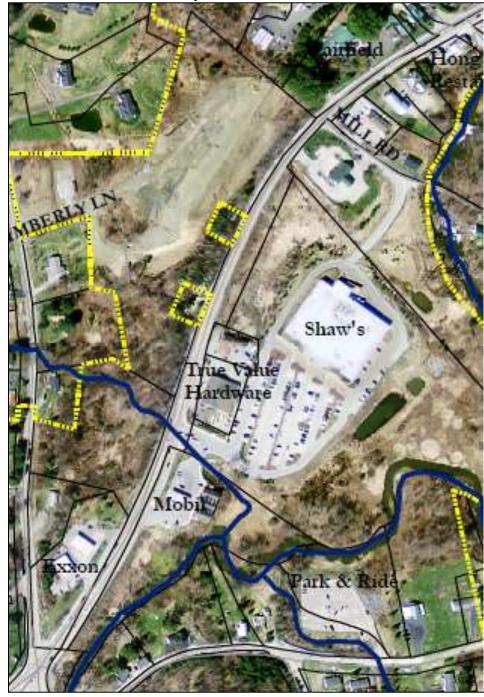
Illustration 2: Detailed Study Area

To make sure that the preferred alignment could connect easily with other possible walking and bicycling improvements in Colbyville, the BRPD Team expanded the Detailed Study Area, shown in **Illustration 2**, to include all of Lincoln Street and other nearby roads and land. **Illustration 3** shows this Expanded Study Area. Most of the information in this report focuses on the Detailed Study Area, but where appropriate, it enlarges its focus to include the Expanded Study Area.

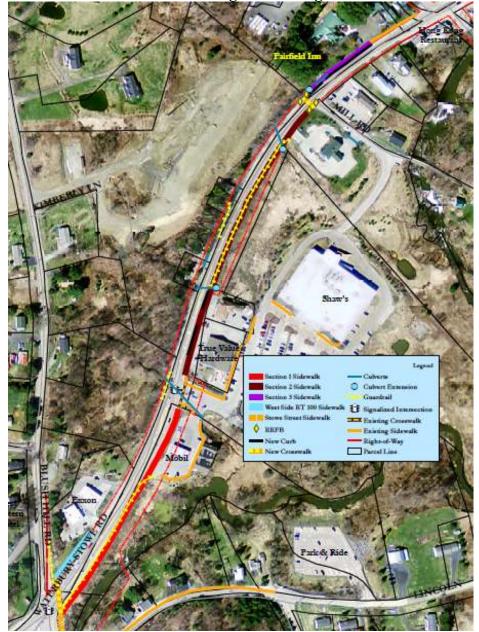
Illustration 4: The Preferred Sidewalk Alignment along Route 100

The recommended alignments (or preferred alternatives) would create a continuous sidewalk along Route 100, between the intersection with Stowe Street and Blush Hill Road at the southern end and the intersection with Crossroad and Laurel Lane at the northern end. In total, the sidewalk would be 2,200 feet long. It would be located on the east side of Route 100 for most of the route. Starting at the southern end, it would cross Route 100 at the intersection with Mill Road and continue along the western side of the road until it meets with the existing Fairfield Inn sidewalk. The sidewalk would lie within the Route 100 rightof-way on most portions of the east side and almost entirely within the right-of-way on the west side.

A crosswalk on Route 100 near Mill Road would eventually link the sidewalks on either side of the road. The proposed location of the crosswalk meets sight distance requirements in both directions. However, because of the high volume of vehicular traffic on Route 100 and the potential for significant night time use by hotel guests, the Town is interested in providing additional protections for pedestrians at this crosswalk. **Figure 4** shows the preferred alignment of the Route 100 sidewalk; **Figure 5** graphically shows the issues and recommendations associated with these preferred alignments.

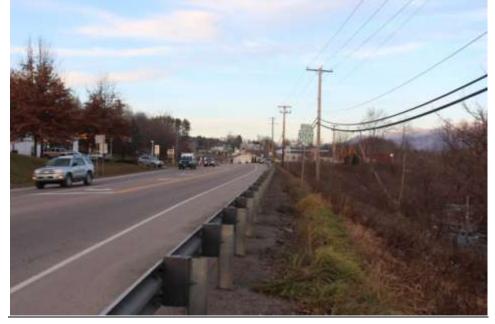
Route 100 looking north just north of Stowe Street in Section 1

The preferred alignment in Section 1 adds a sidewalk behind the new guardrail on the southeast side of the road. The paving project will replace the guardrails in the same location as the existing guardrail, seen in the photo above. Sidewalk installation will require retaining walls to create a level area for the sidewalk for the distance between Stowe Street and the southern entrance to the Mobil gas station. The retaining walls would also protect Thatcher Brook and the wetlands that lie at the bottom of the slopes. The retaining wall between Stowe Street and the entrance to the Mobil gas station would be approximately 500 feet long and about six feet high. **Illustration 5** provides a typical cross section of this alternative in those locations where a retaining wall is needed. As **Illustration 5** shows, a railing or fence would sit on the top retaining wall, adjacent to the sidewalk. The other edge of the sidewalk would be separated by at least one foot from the outside, adjacent edge of the guardrail supports.

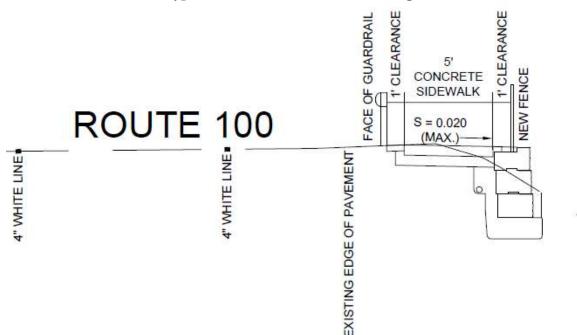
Illustration 5: Section 1 Typical Cross Section with Retaining Wall

The curved end of the guardrail next to the Mobil gas station would need to be redesigned to allow the placement of the sidewalk. The signs along the edge of Route 100 would be relocated to be on the outside of the sidewalk on top of the retaining wall. (Signs could also be placed between the sidewalk and the road, adjacent to the guard rail, but there is a concern that they might extend beyond the edge of the guardrail and create a hazard for snow plows.) Three utility poles along the portion of Route 100 between Stowe Street and the southern entrance to the Mobile station would need to be moved to make room for the retaining wall and sidewalk. A fourth pole close to the Stowe Street/Route 100 intersection might also need to be relocated, depending on the final design of the retaining wall and sidewalk.

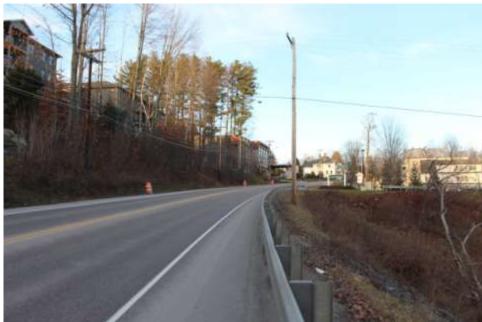
Looking north on Route 100 towards Community Bank

The sidewalk in Section 2 would start from the end of the existing sidewalk that runs along the north side of the Shaw's Driveway ending at Route 100. The existing wooden tie planter, seen in the photo to the right, would be removed and replaced with a concrete curb at the outer edge of the Route 100 pavement. The sidewalk would lie directly adjacent to the curb, raised a minimum of six inches above the surface of the adjacent Route 100 and parking

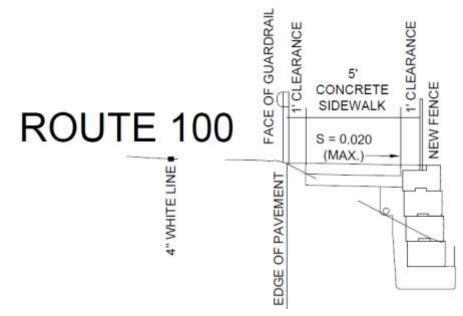
Illustration 8: Section 2 Typical Cross Section with Retaining Wall

North of the Car Care car wash, the sidewalk would lie behind the new guardrail, which the paving project will locate in the same location as the existing guardrail seen in the large photo at the beginning of this description. The retaining wall would create a level space for the sidewalks; it would be approximately 515 feet long and five feet high. **Illustration 8** on the next page provides a typical cross section of this alternative. The sidewalk would be approximately one foot behind the guardrail supports. A fence or railing would top the retaining wall. The curved northern end of the guardrail at the south side of the Merchant's Bank driveway would need to be modified to allow the placement of the sidewalk behind it. Construction work would need to provide protection for the water line under portions of the proposed sidewalk.

The culverts under Route 100 just north of the Car Care parcel, just south of the Merchant's Bank parcel, and in between these two would need to be extended to allow construction of the retaining wall for the sidewalk. The culvert might come through rather than go under the retaining wall, depending on the final design of the wall and the culvert extension. Because the condition of the culverts is noted as being "unknown" in the state data base, the condition of the culverts would need to be verified before extensions could be designed. If the condition of any of the culverts is not acceptable, the Town might need to coordinate the replacement of the culverts with VTrans. The costs of replacing the culverts would need to be included in the cost of the sidewalk project.

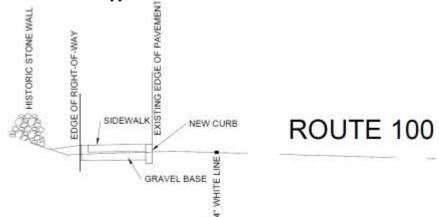
Illustration 10: Section 3 Typical Cross Section next to Stone Wall

outside of the right-of-way. A slight curved length of sidewalk would join the new sidewalk with the existing sidewalk. The BRPD Team anticipates that the utility pole seen in the photo should be able to remain in its current location, but this would need to be verified after the paving project has been completed. **Illustration 10** shows a typical cross section of the sidewalk adjacent to the stone wall. **Illustration 11** shows as typical cross section adjacent to the stormwater retention area surrounded by a fence.

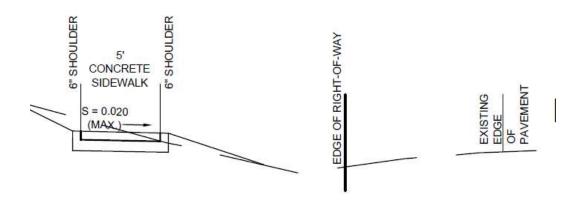
Illustration 13: Typical Cross Section Route 100 West Side

The preferred alignment includes a recommendation for a short section of sidewalk on the west side of Route 100 extending north from Blush Hill Road to the southern paved Shell gas station access drive. The five-foot sidewalk would be located outside of the Route 100 right-of-way on the adjacent Shell Gas Station property so that the existing drainage ditch, located to the left side of Route 100 in the

side slope to create a level area large enough for the sidewalk. The amount of cut and fill increases as the sidewalk gets nearer to Blush Hill Road.

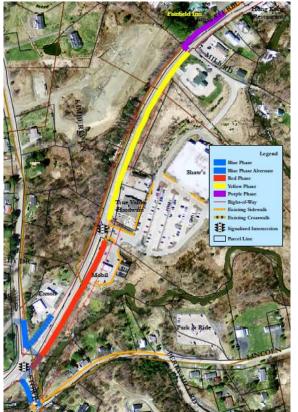
Illustration 14: Proposed Route 100 Sidewalk Phases in the Primary Study Area

VTrans requirements mandate that each phase of a project must stand on its own as a viable sidewalk that would not require the addition of other phases to be useful. This ensures that if only one phase is ever constructed, it would still be a usable improvement. With this in mind, the four phases are suggested because they each provide a link between important destinations identified during the examination of existing conditions.

Based on the input from the Steering Committee and the public, the Red Phase would be the more important section to build and would therefore be appropriate to consider as the first step, as well as the Stowe Street portion of the Blue Phase. However, because of the high cost retaining wall, it might not be possible to pursue development of the Red Phase immediately. In that case, the complete Blue Phase would be the most appropriate first step, because it completes the Stowe Street sidewalk, provides crosswalks for Stowe Street and Route 100, and ends at one of the destinations noted in the need for the project.

Between the Yellow Phase, Sections 2 and the Purple Phase, Section 3, either could be considered as the next phase, depending on what is most important to the community at the time that they are being considered. Section 3 would provide an extension southward of the existing Fairfield sidewalk. The associated crossing at Mill Road would provide a link to Mill Road itself and then the sidewalks within the Shaw's parcel. Section 2 would provide a visual as well as actual extension of the Red Phase and would allow individuals to get up to the Fairfield Inn. If Section 2 were constructed as the second phase, it would be advisable to include the crosswalk to the west side of Route 100, along with the southernmost part of Section 3 from the crosswalk to the Fairfield Inn driveway.

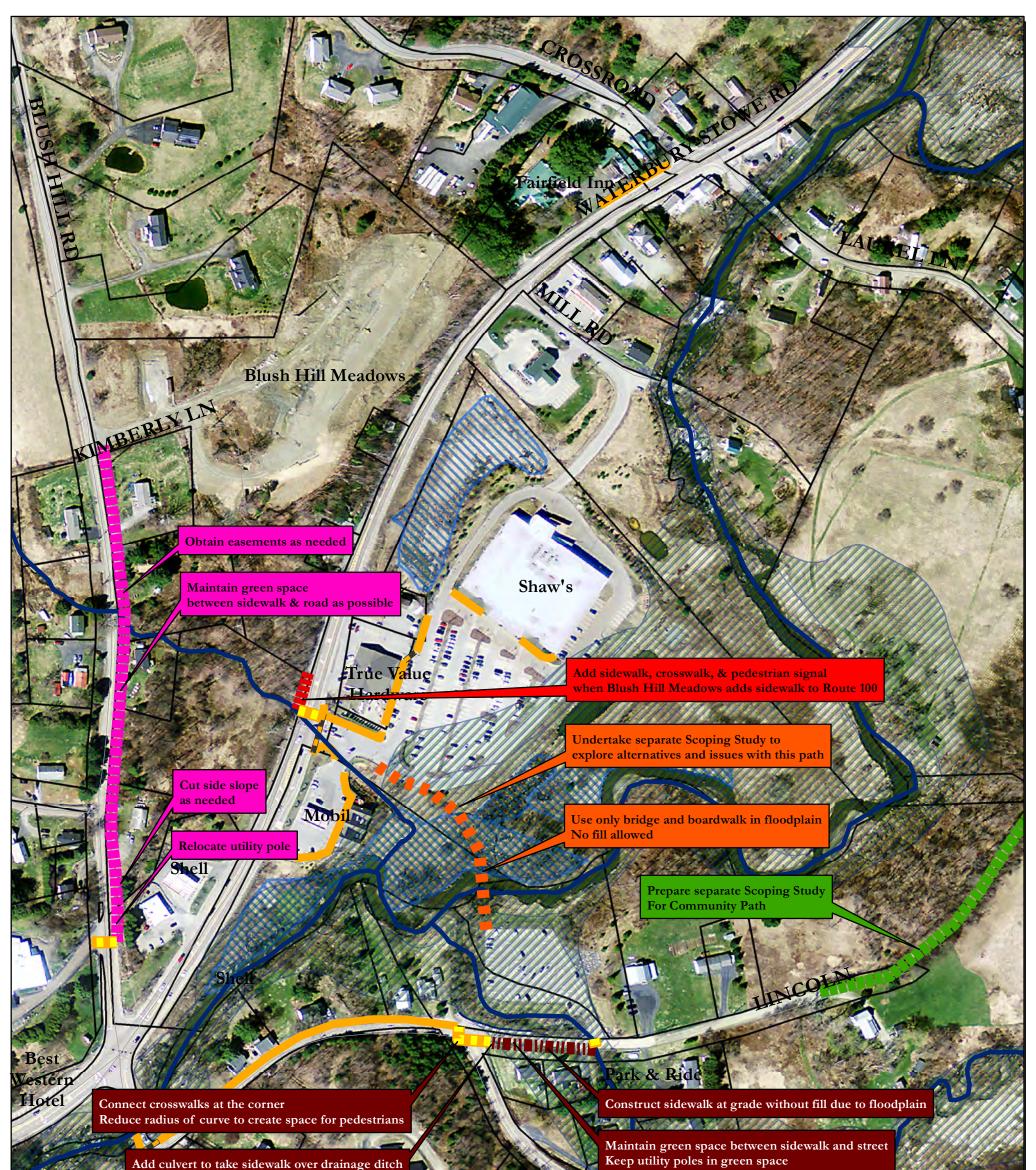
Add culvert to take sidewalk over drainage ditch
