**Waterbury BO 1446(40)**  
**Bridge #36**  
**Scoping Study**  
Project Definition  
Stowe Street over Thatcher Brook

4/27/2021

Vermont Agency of Transportation (VTTrans)

Stantec Consulting Services (Stantec)  
55 Green Mountain Drive  
South Burlington, VT 05403

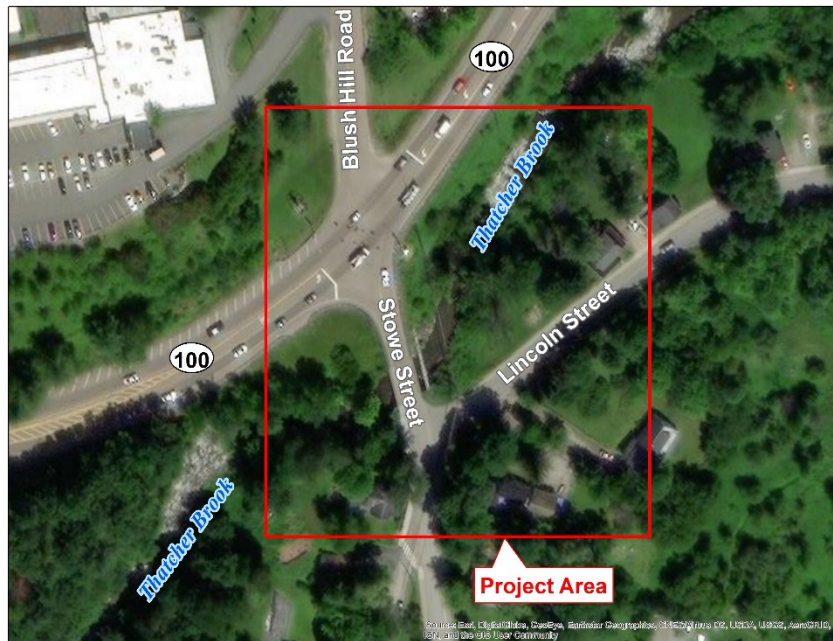
**Figure 1 Project Location Plan**

The project area is centered around Bridge 36, where Stowe Street passes over Thatcher Brook. The project area also includes the intersection of VT 100 / Stowe Street and Stowe Street / Lincoln Street, as shown in Figure 1.
