# Edward Farrar Utility District Waterworks Property Landscape Inventory & Assessment

**Spring 2026**

Authors: Lena Andrews, Isaac Buabeng, Clara Chaisson, Gordon Coates,  
Rachelle Klapheke, Summer Lang Moeller, Michelle Lockhart, Lindsey Monteith,  
Annie Nelson, Darian Rubow, Nick Sibley, & Zoë Smiarowski

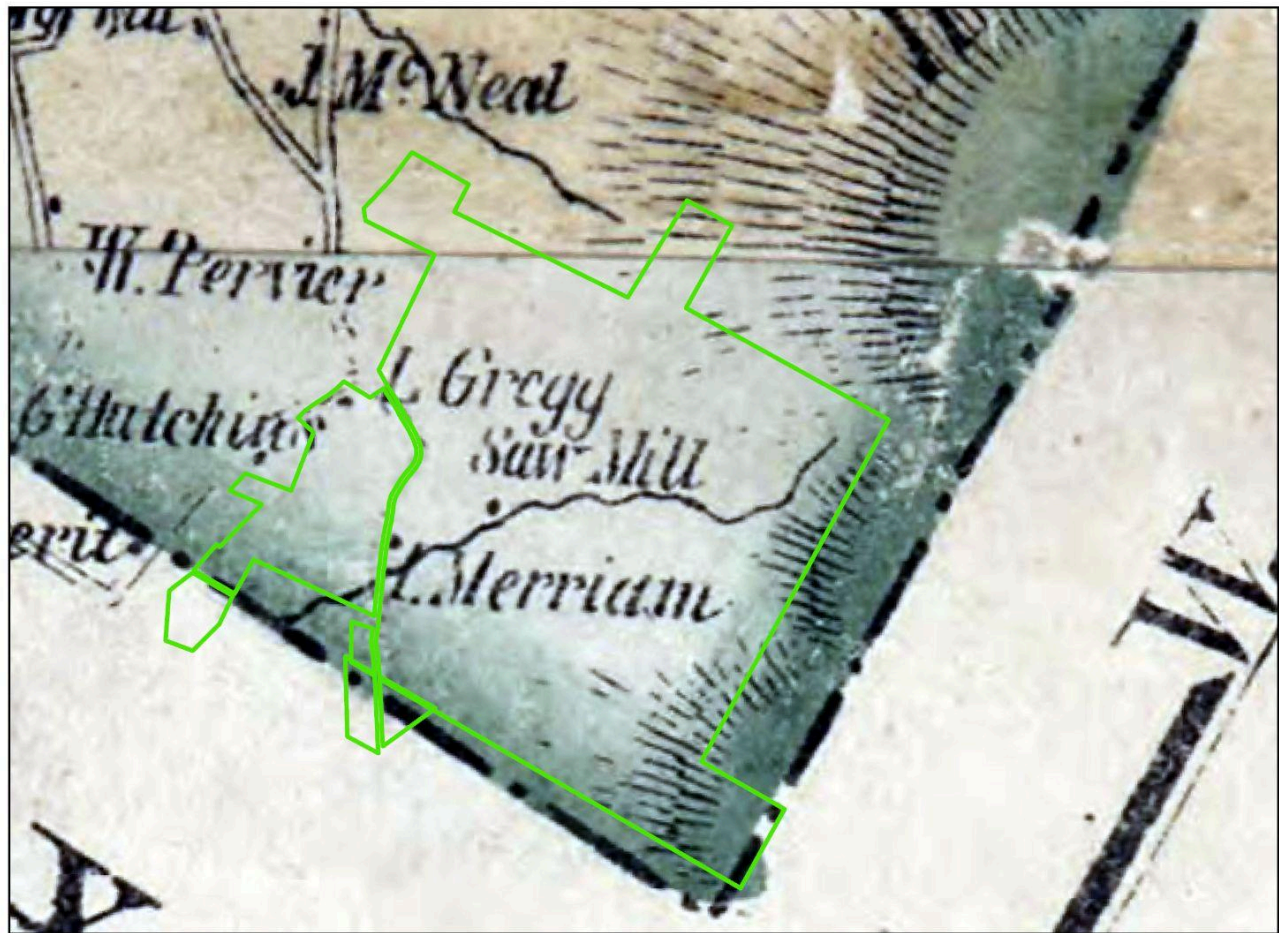
## 1859 Walling Map of Stowe with EFUD Boundary Overlaid

In order to piece together post-colonial land use on the site, we referenced the historic Beers Atlas maps and Walling County maps for both Lamoille and Washington Counties, visited the Stowe Town Clerk to look at deed records, accessed Special Collections at the University of Vermont to reference agricultural census data, utilized Newspapers.com's archives of digitized records to search for both names of known inhabitants and instances of the mention of the Waterworks, sourced LiDAR data to locate instances of cellar holes and stone walls on the Waterworks, searched historical photos and documents on the Waterbury Historical Society online collections, and consulted with research specialist Samantha Ford.

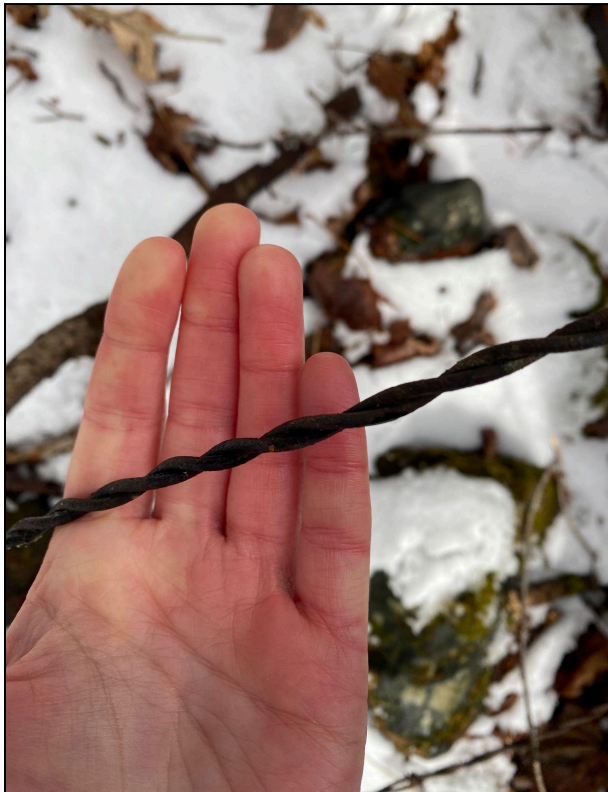
There is much evidence of this land use still on the Waterworks today. Near the main entrance, there are the remains of the cellar of an English-style house constructed with stacked stones, likely from the late 1800's or early 1900's. In the nearby stream, a square structure still stands, made of cement which indicates it was constructed less than 100 years ago. Along the road and between existing structures we still see evidence of stone walls, some of which are quite extensive. One stone wall still contains three rows of wire, both with and without barbs, indicating the presence of sheep, which would have required barbless wire to prevent their wool getting entangled (Samantha Ford, personal communication, April 6, 2026).

Figure 6: Barbless wire, one of three wires found within a stone wall on the Waterworks.

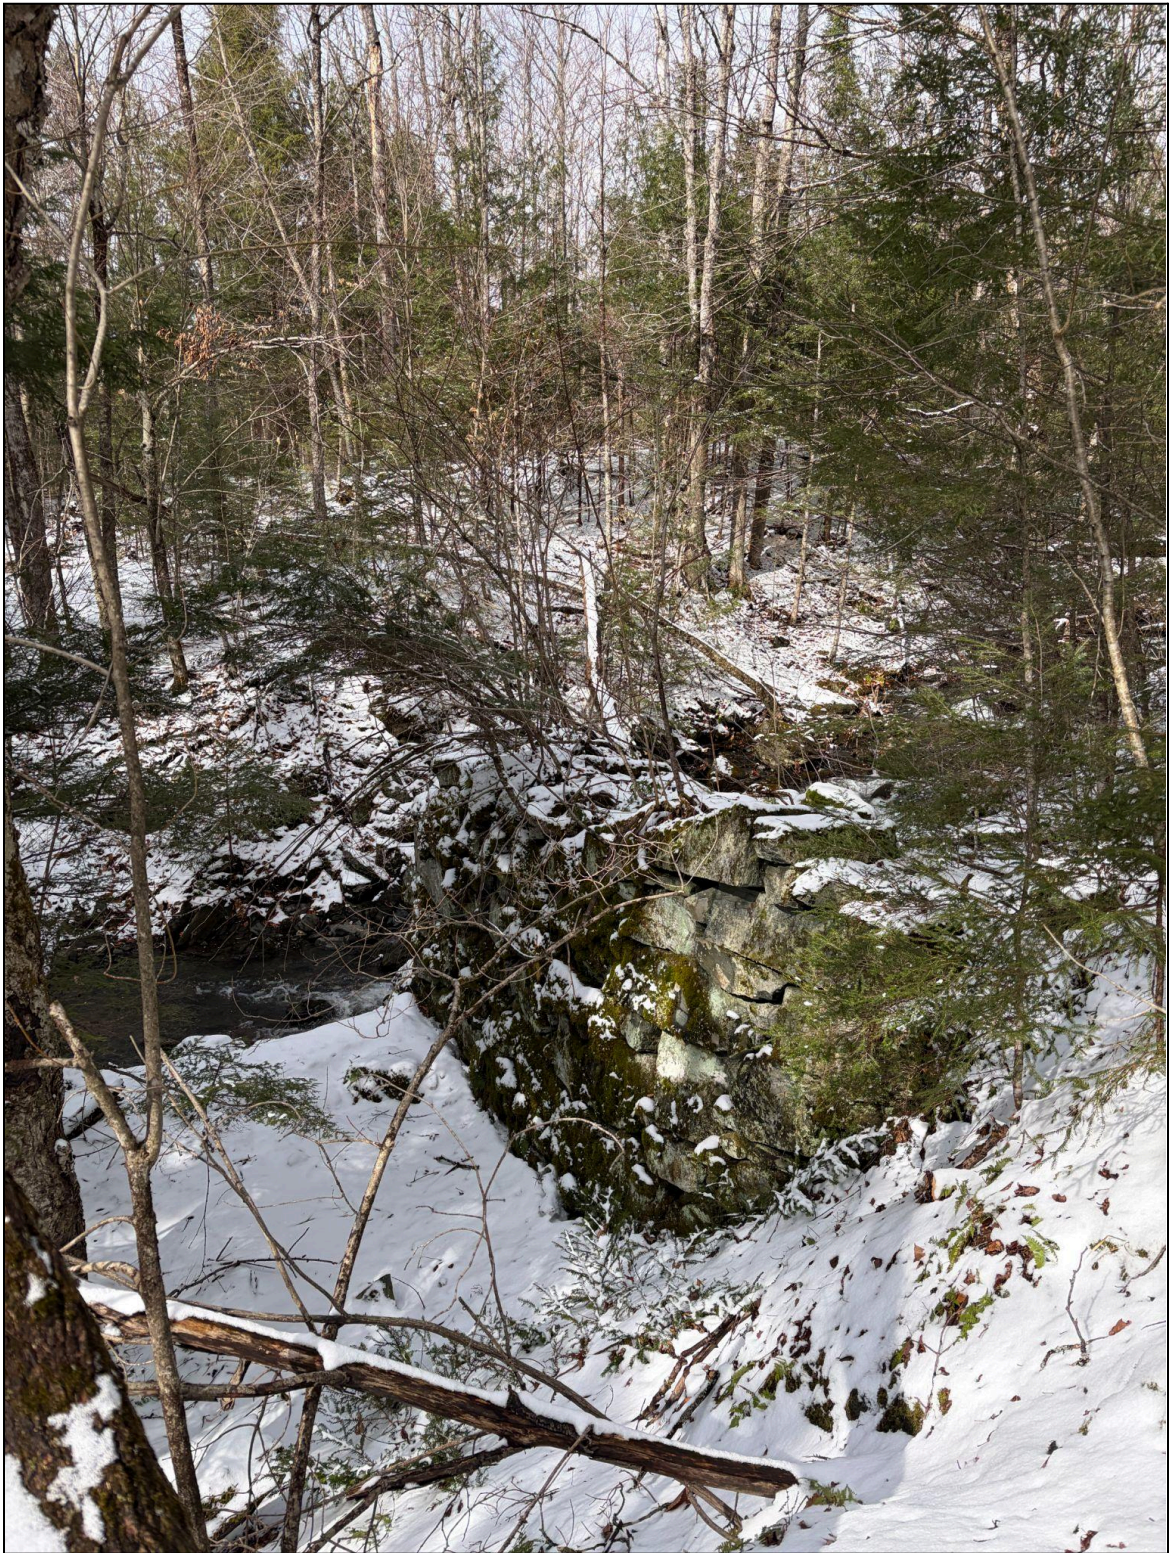
In the brook at the corner of the pasture, there was likely a steam mill. The largest cellar remains consist of a foundation including large stones, mortar, and handmade bricks. This foundation was likely not that of a home, and would probably date to circa 1860.

Figure 8: Evidence of historic mill infrastructure on Thatcher Brook.

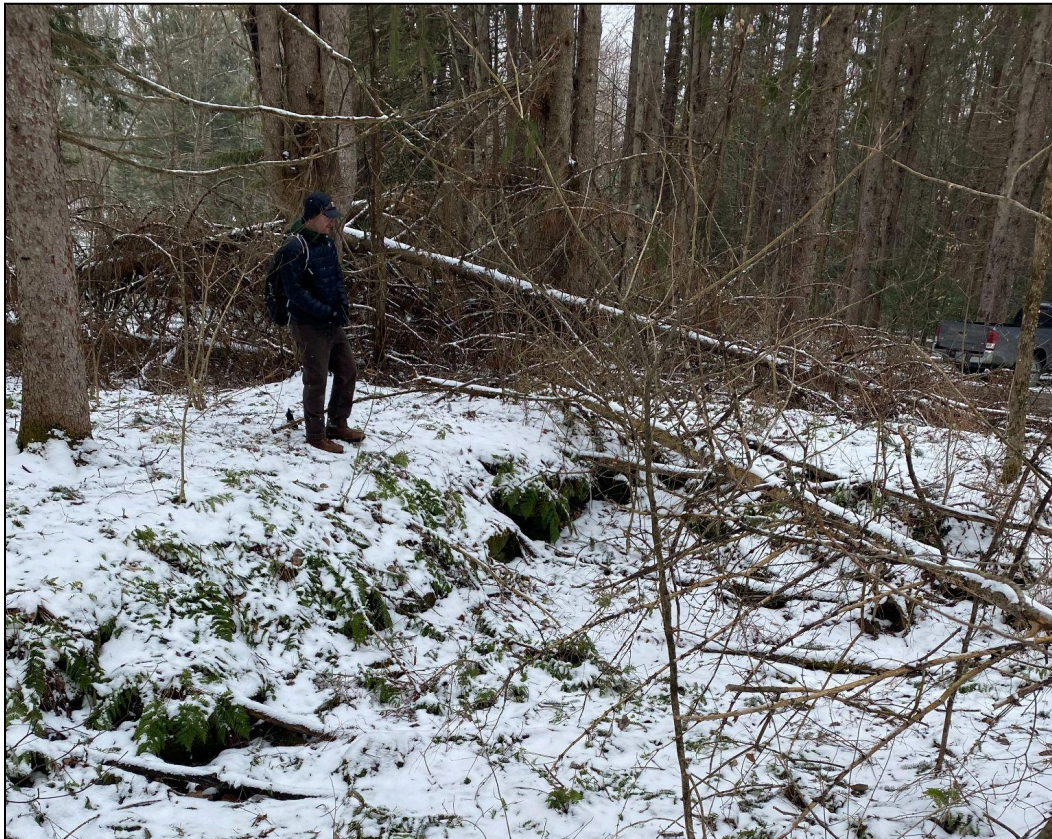
Figure 10:  
Foundation 1,  
referenced in  
Figure 9  
above.

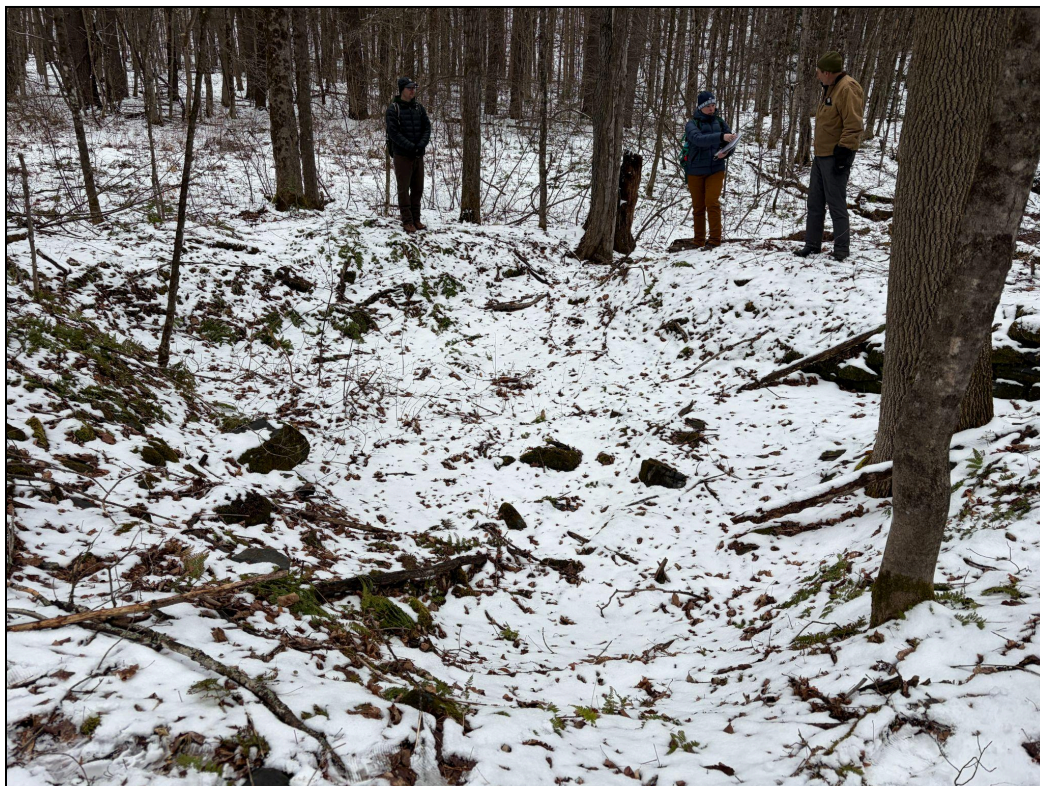
A second cellar hole, made of smaller stones, is likely somewhat older than the first, possibly from the mid-1800's. It is thought to have been Isaac Merriam's home with his wife, Mary, and their eleven children (Samantha Ford, personal communication, April 6, 2026).

Figure 11:  
Foundation 2,  
referenced in  
Figure 9  
above.

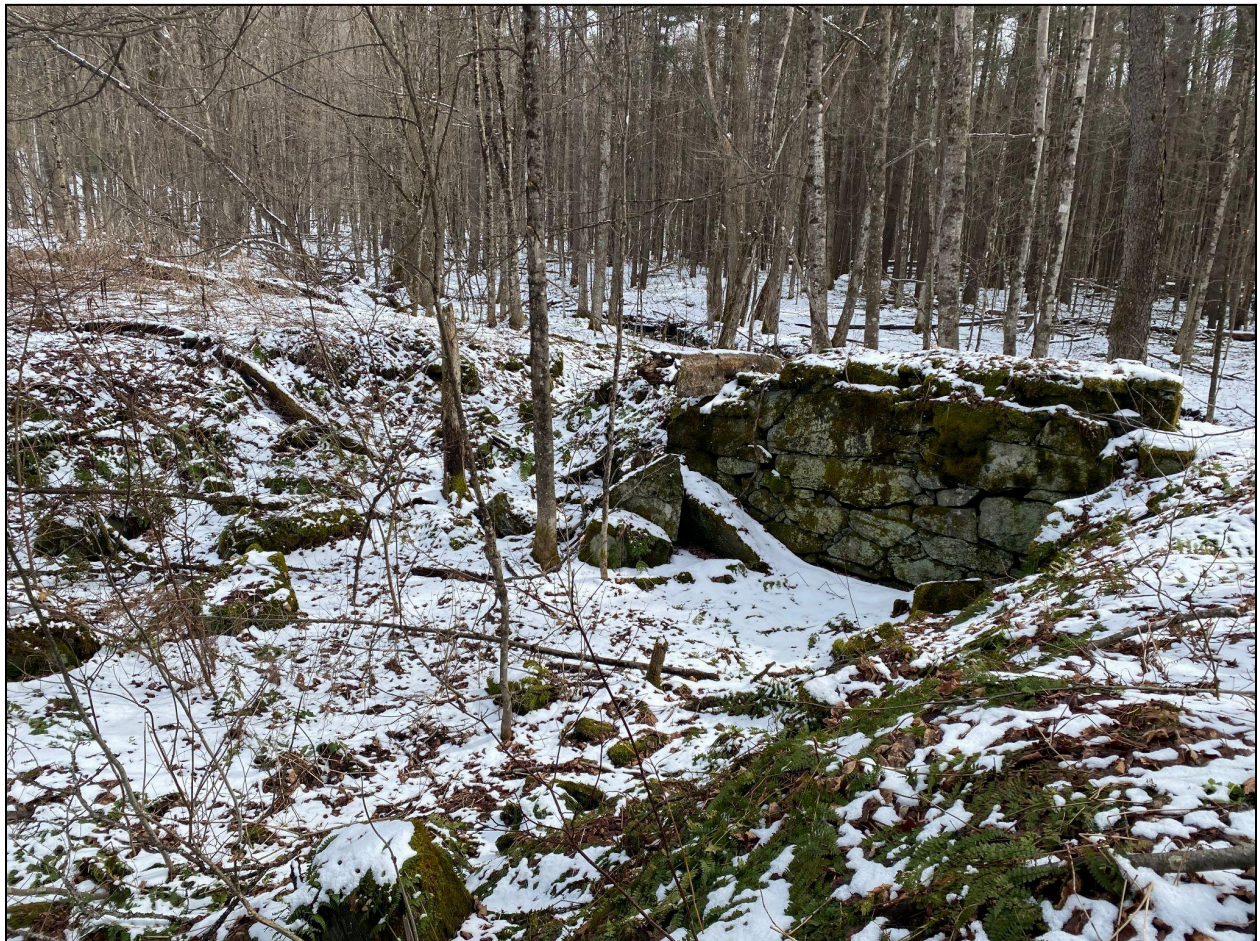
Figure 12: Foundation 3, referenced in Figure 9 above.

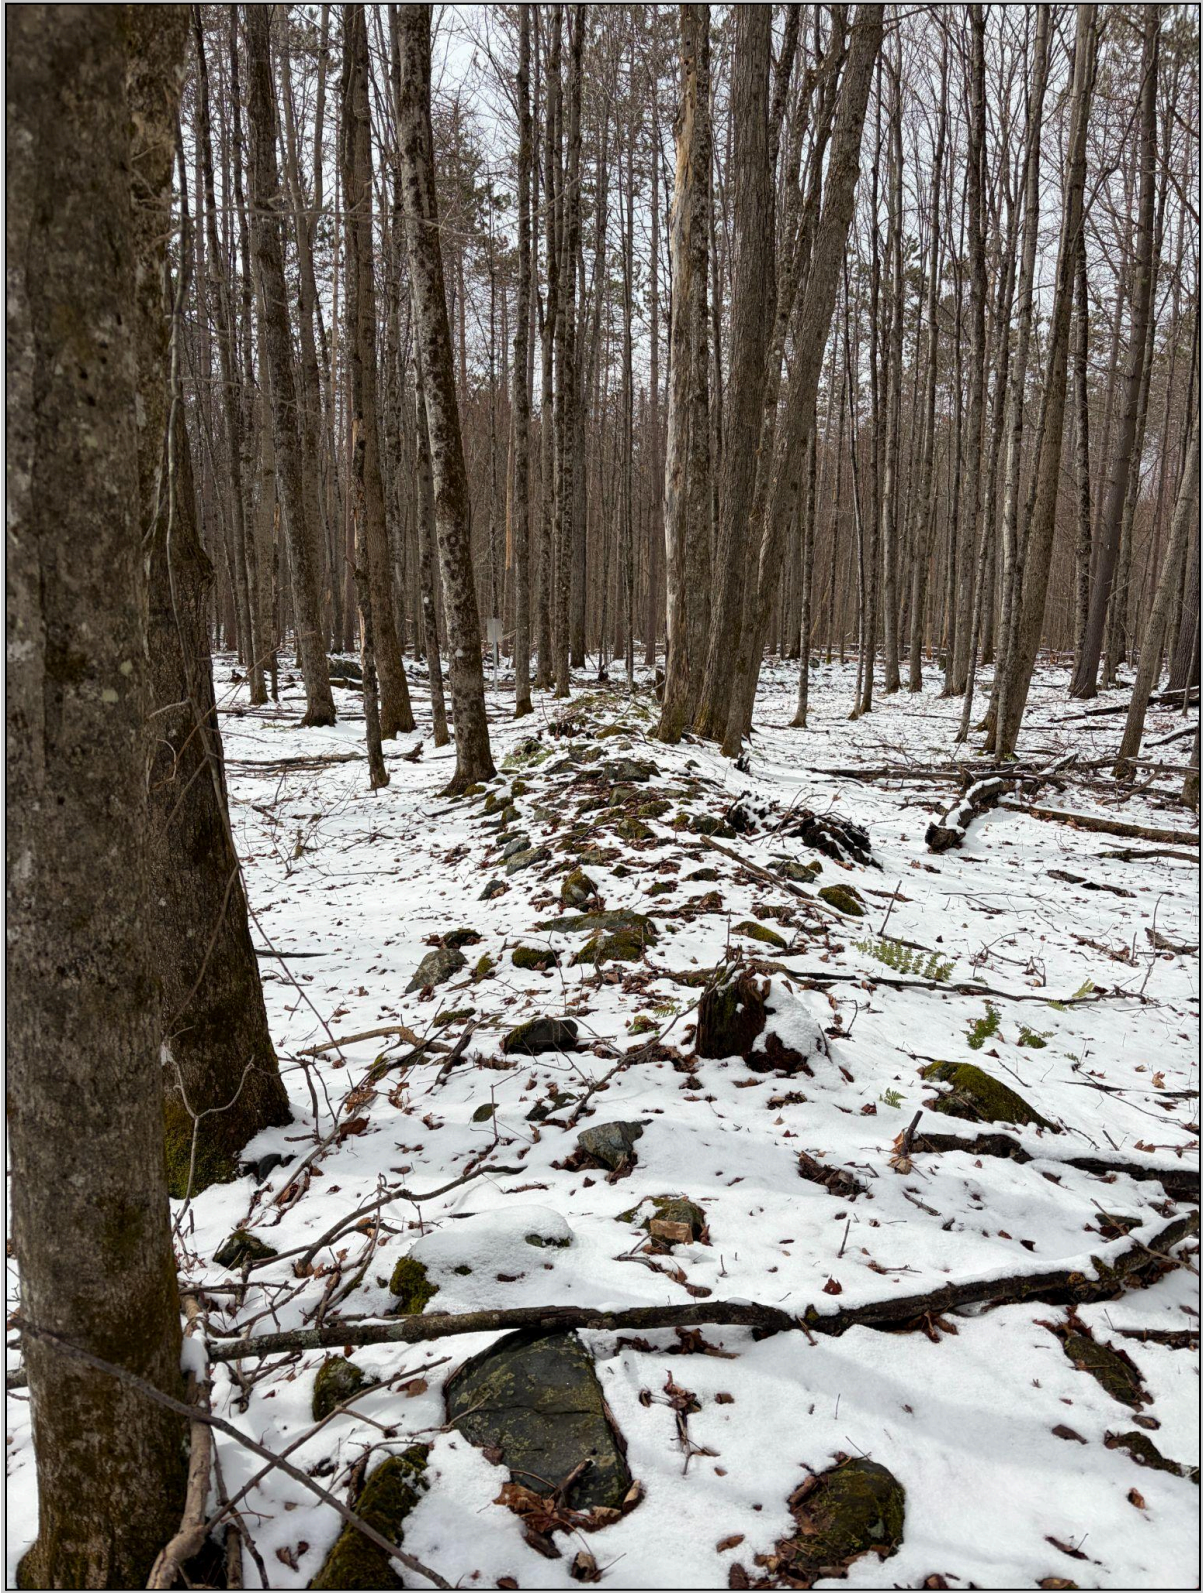
Figure 13: Stone walls, referenced in Figure 9 above.

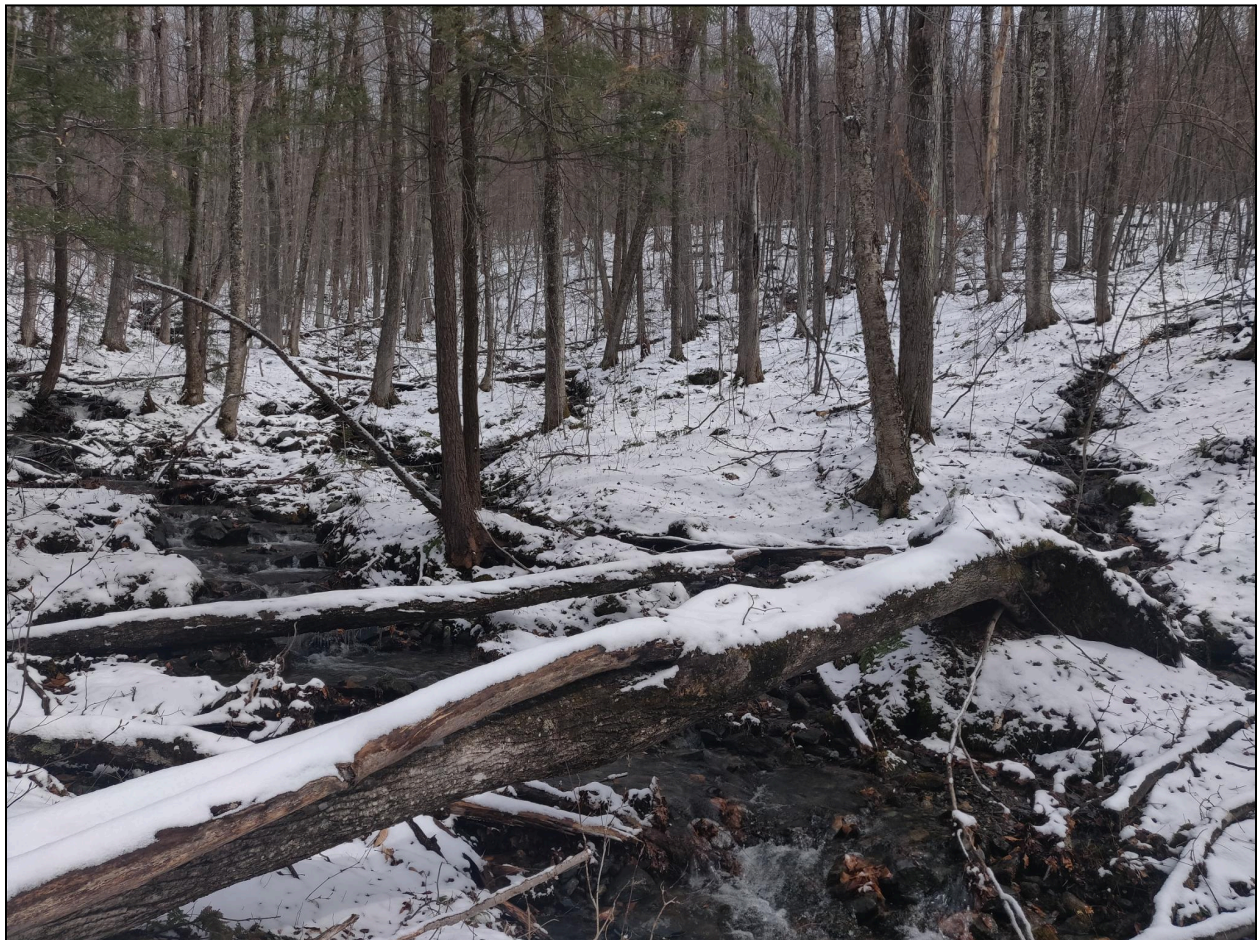
Figure 21: Two streams merging upland on Merriam Brook, neither of which shows up on existing maps.

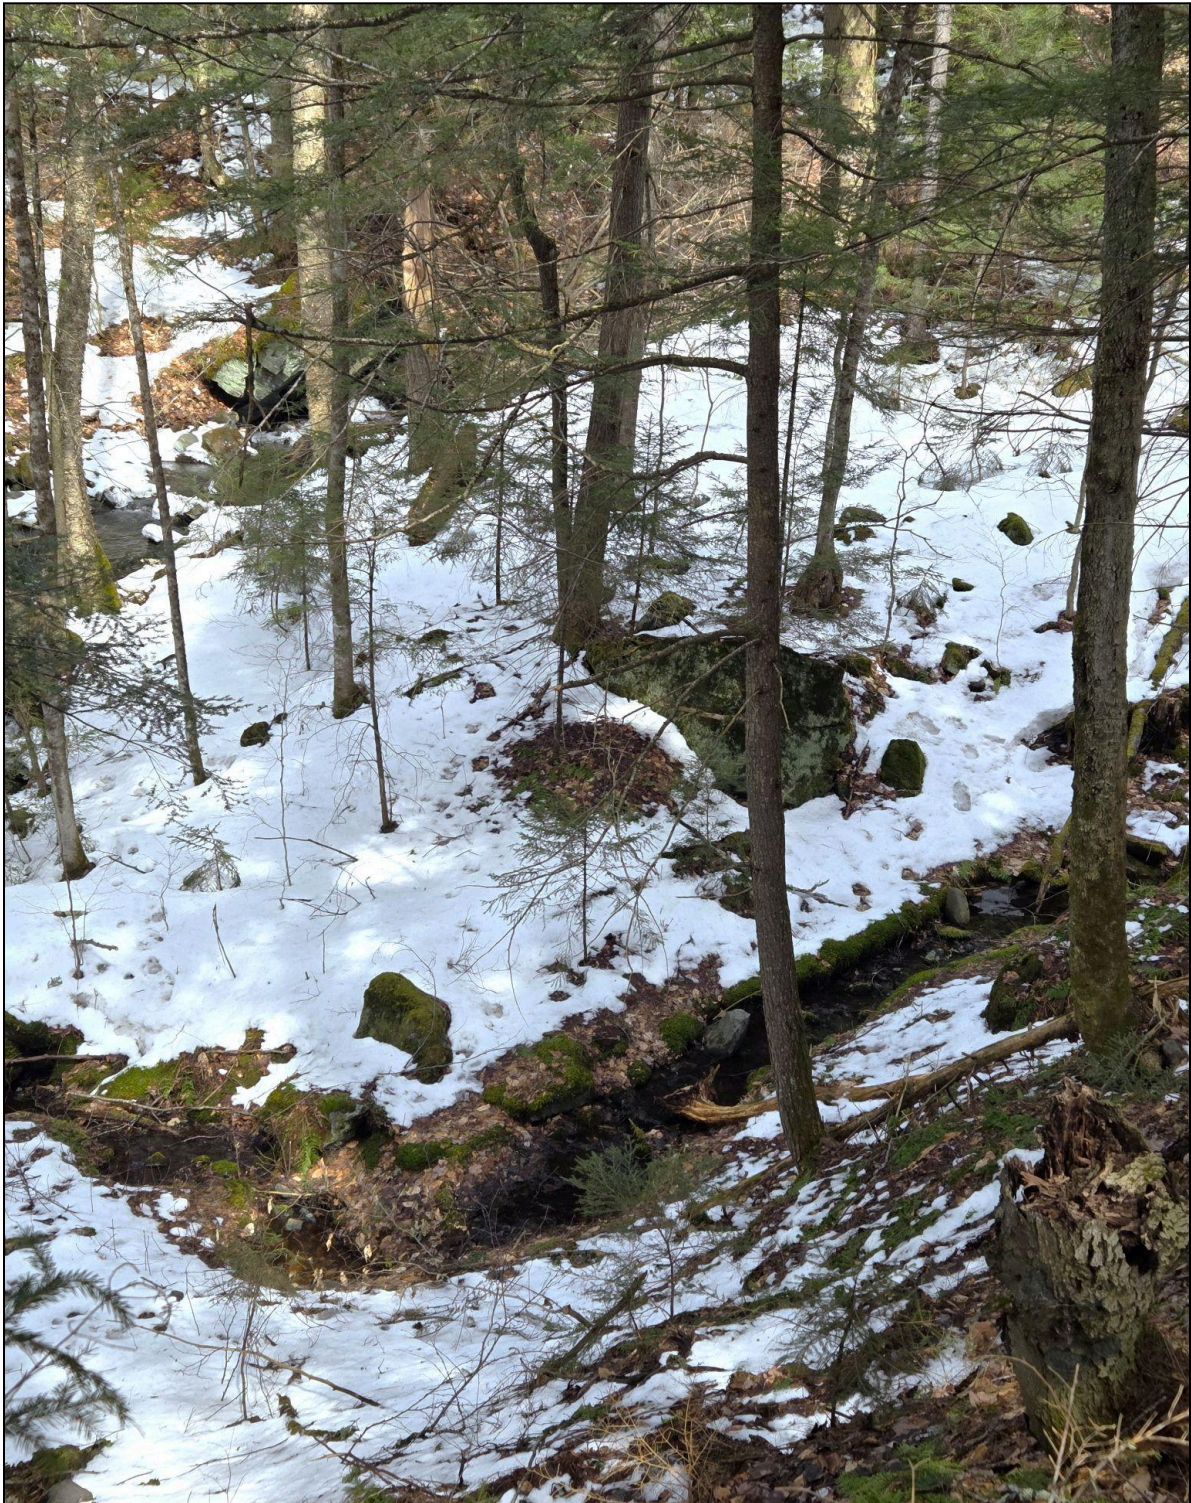
From Well #1 to the southern boundary of the Waterworks, only ~200 feet of elevation gain defines a more gradual slope for the southwestern quadrant. This gentler slope allows Tyler and Thatcher Brooks to widen, deposit sediment, and merge near Waterworks Road. All of the

streams contribute sandy sediment at the base of the mountain. This sandy soil is more prone to erosion and will allow streams to shift, widen, and meander over time.

Figure 22: View down to Tyler Brook in the steeper northeastern section of the Waterworks.

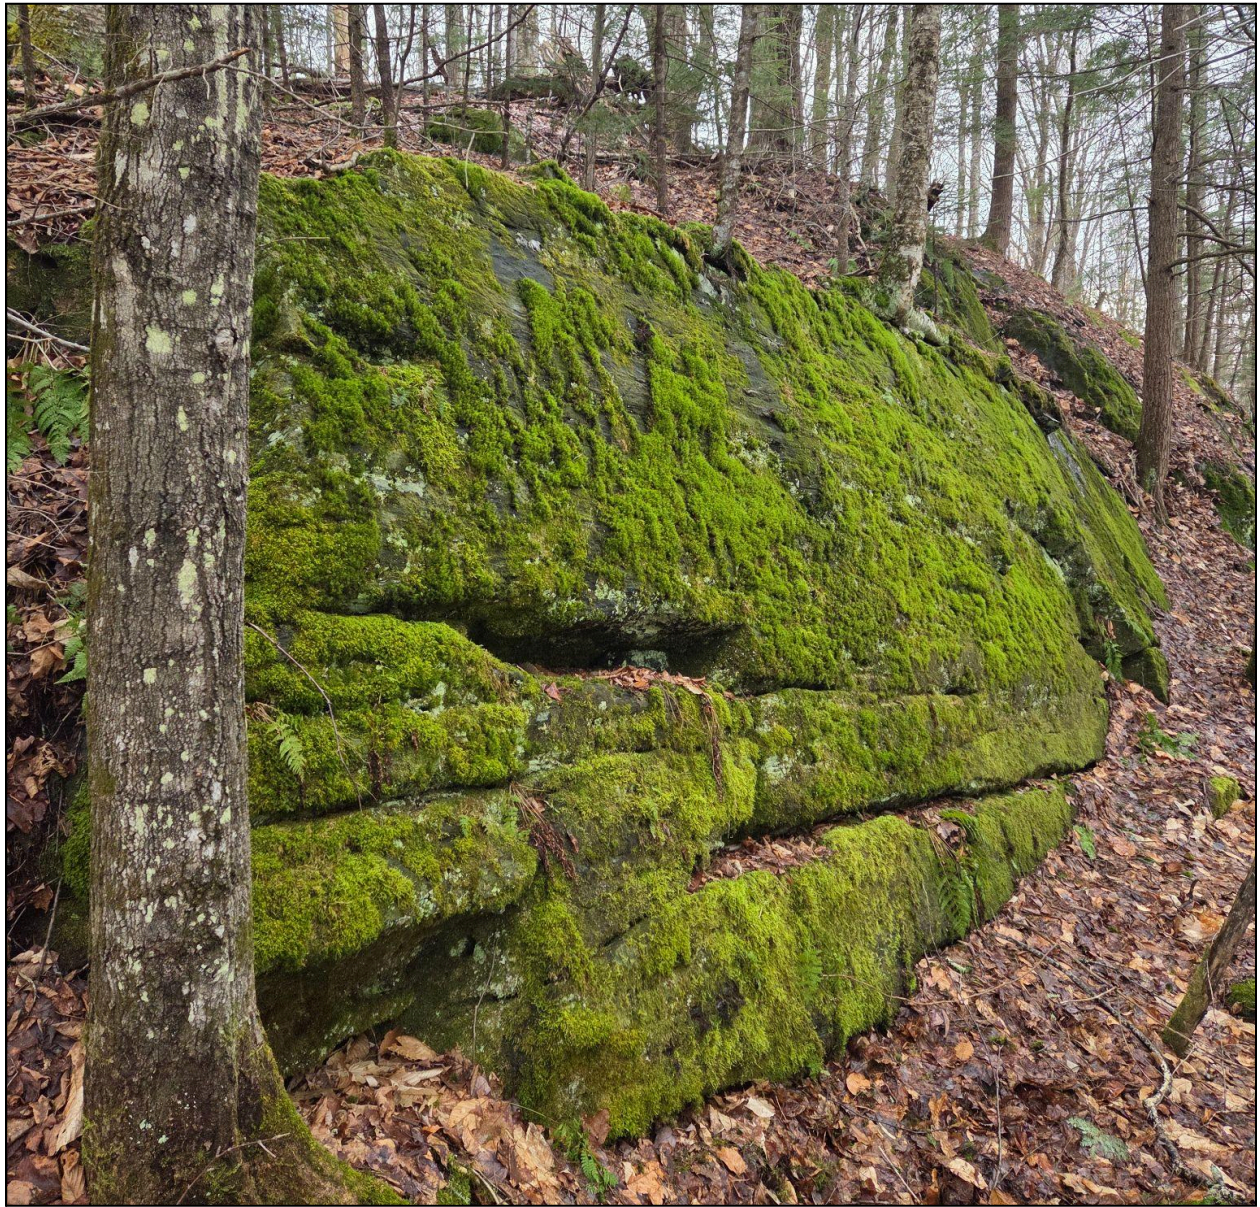
Figure 23: Exposed bedrock near Tyler Brook north of Waterworks Road with visible fractures revealing how water may move through rock layers underground.

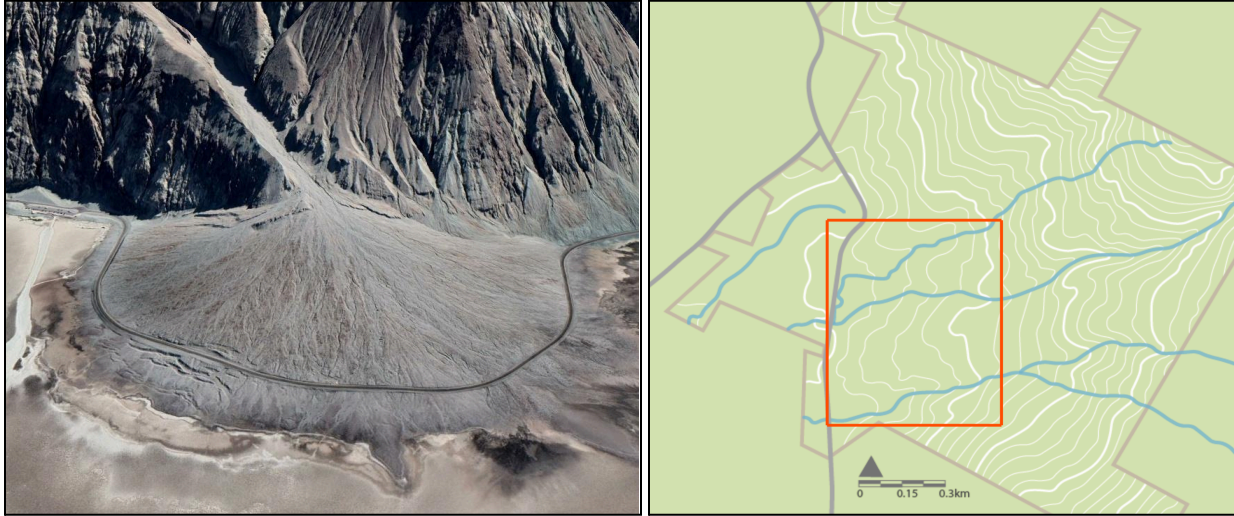
Some soil deposited by the glaciers was gradually eroded away by Tyler, Thatcher, and Merriam Brooks. This soil flowing downstream is deposited as each stream hits a flatter slope and widens out. Over time, this soil deposition creates a characteristic wedge or fan shape at the bottom of each stream, where newly deposited sediment keeps pushing out previously deposited sediment. These deposits, called alluvial fans, are defined by water flow and made up of moderately erodible soil. They are dynamic landforms where *water flow patterns and soil locations may change over the long-term (decades to centuries) with major floods having the capacity to cause more immediate changes.*

Figure 25 & 26: [Photo of alluvial fan](#) from Google Earth (left) and topography lines from the parcel showing the characteristic cone-shape of an alluvial fan (right).

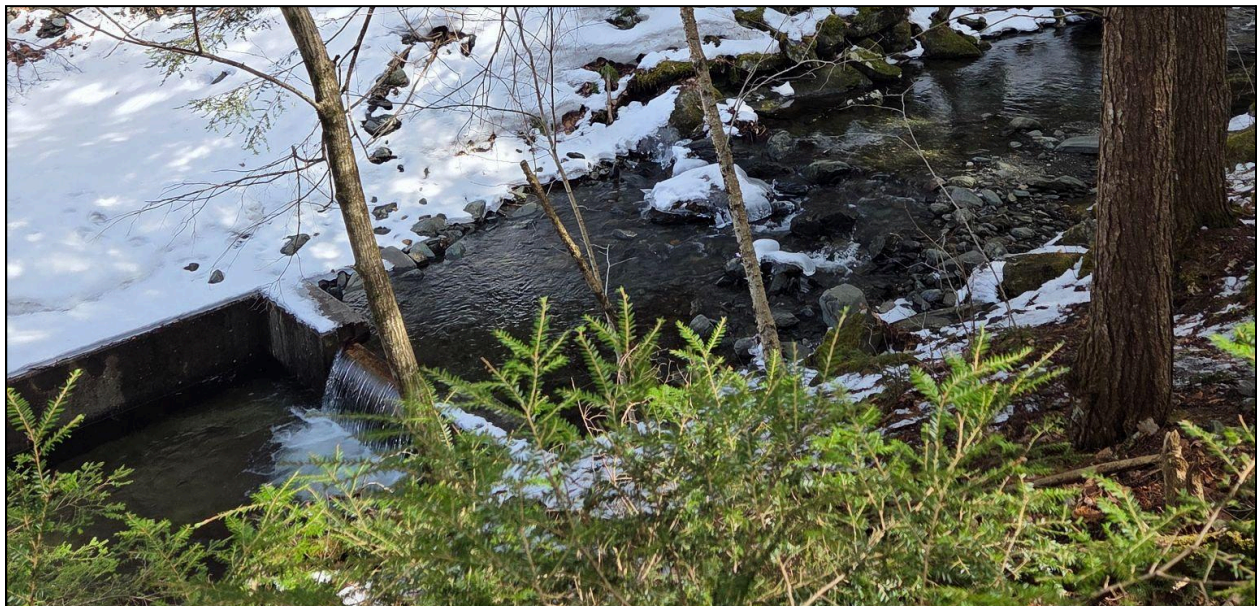
Figure 28, below: EFUD infrastructure along Tyler Brook.

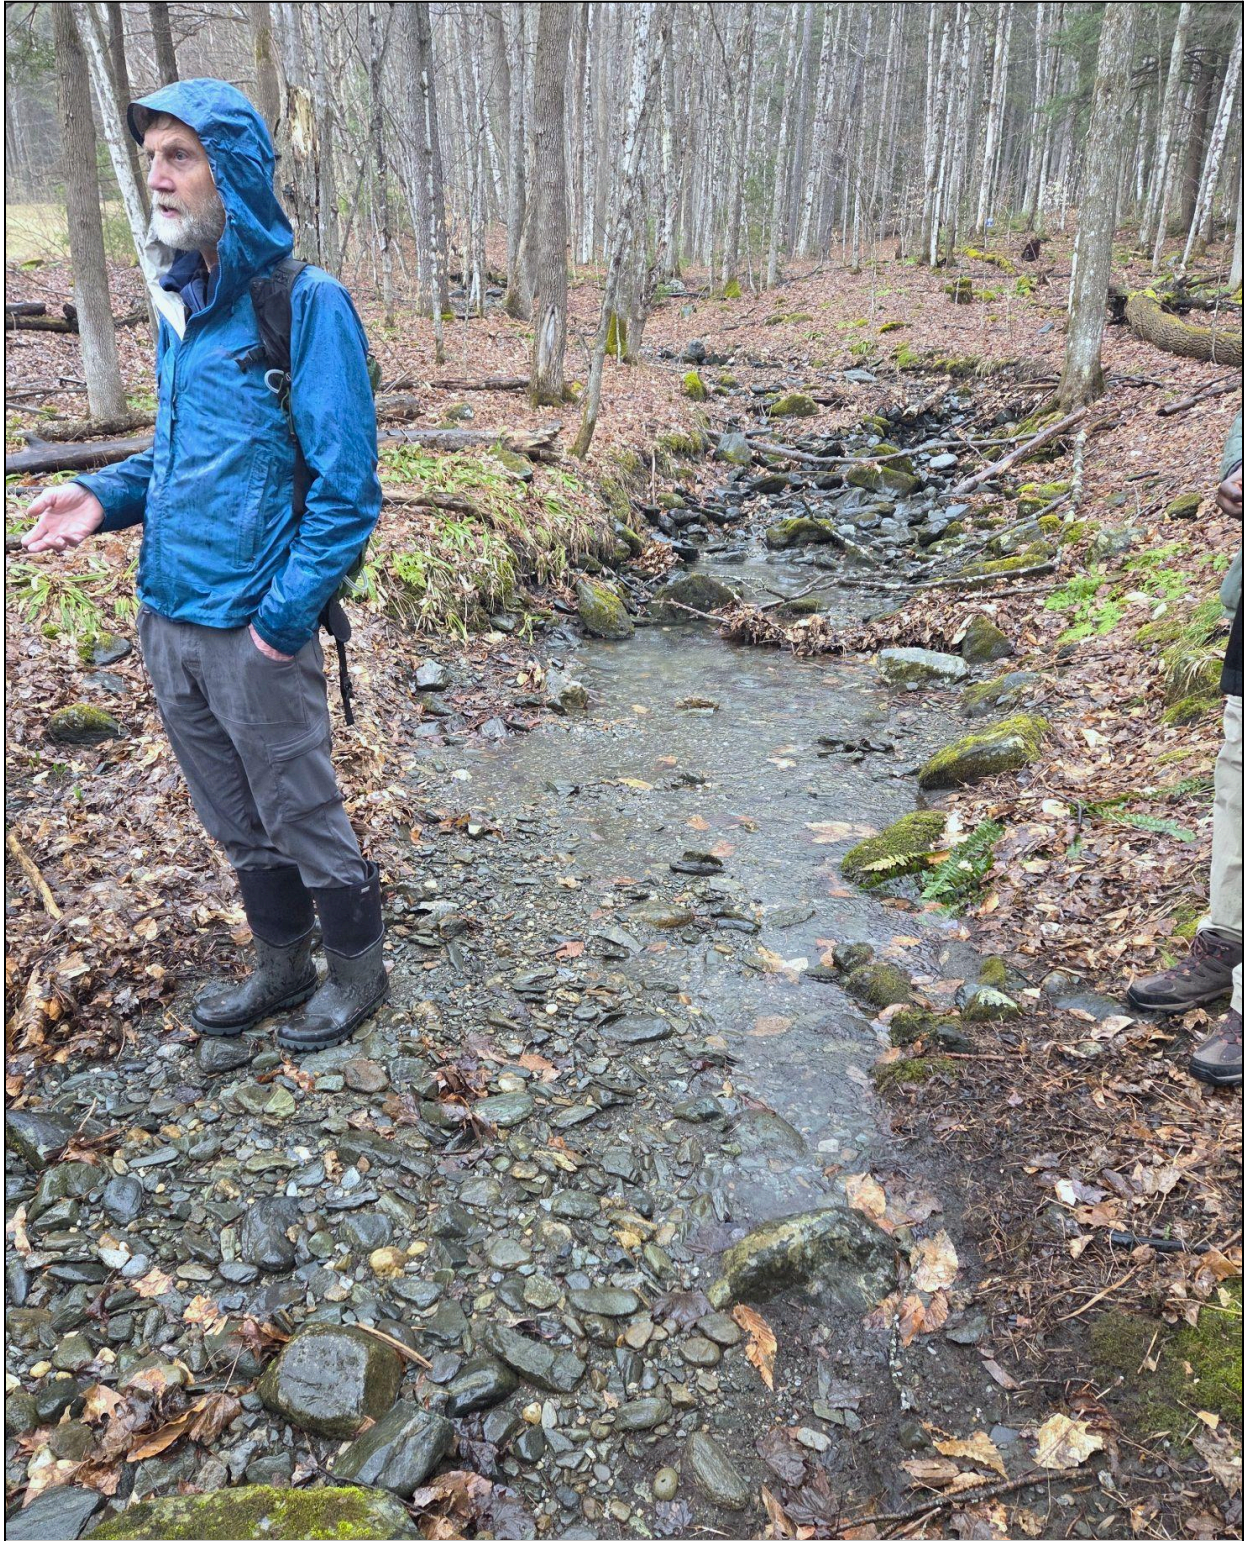
Thatcher Brook just north of Waterworks Road transitions into a losing stream (also called influent stream), which is a stream that disappears into the groundwater system and seems to stop flowing. Losing streams connect with groundwater flow through permeable spaces created by sandier soils and/or fractures in the underlying bedrock.

Figure 31: North of Waterworks Road, Thatcher Brook transitions into a losing stream (a stream that disappears into the groundwater system and seems to stop flowing).

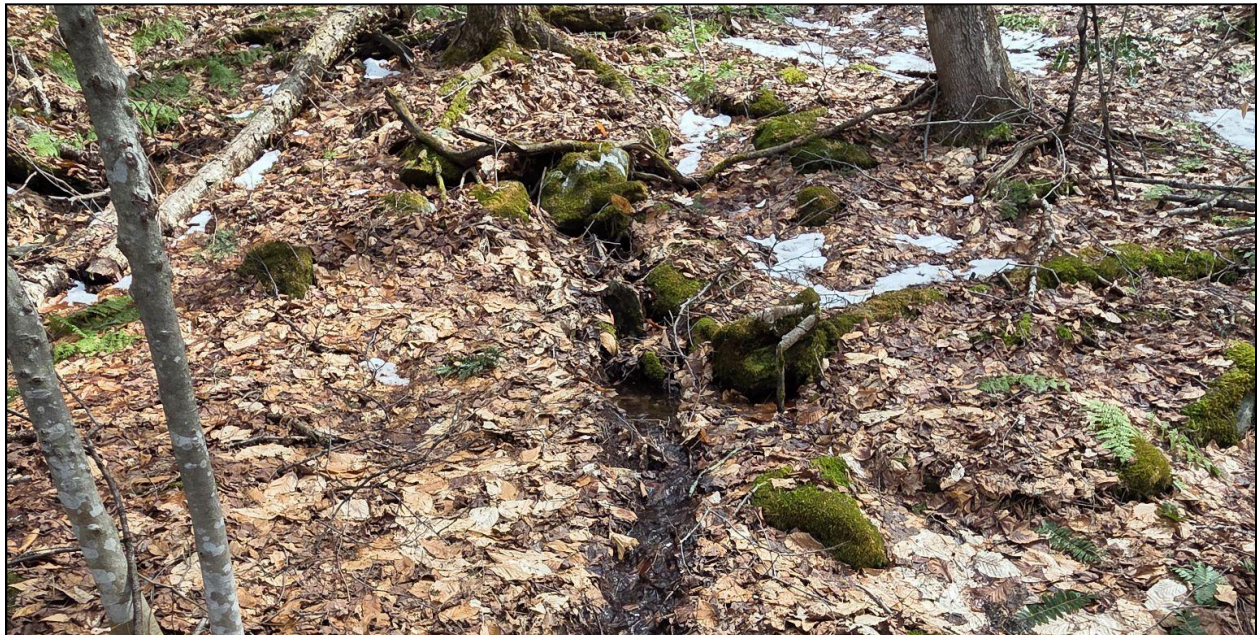
Figure 32: Small, unmapped groundwater seep in the northeastern section of the Waterworks near Tyler Brook

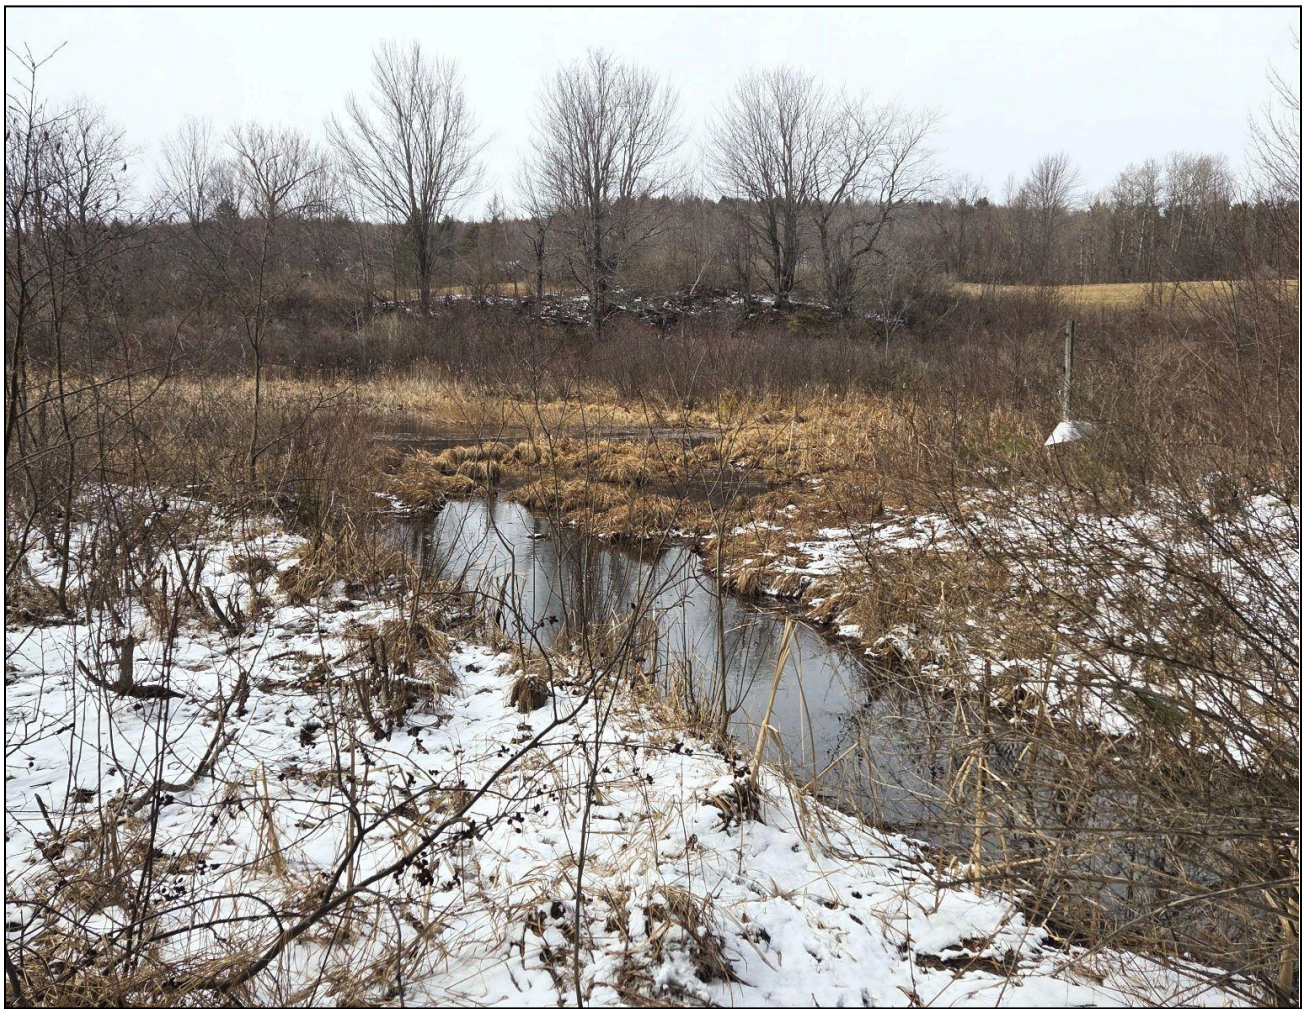
Wetlands, characterized by saturated soils and standing water, are sensitive ecosystems providing rich habitats for fish and wildlife (VT Department of Environmental Conservation, n.d.). Wetlands can act as important buffers during flooding, helping filter out pollutants, including sediment, which might get washed into the streams. On the Waterworks parcel, wetlands are located in the southwest corner. Though this area has sandier soils, high groundwater makes it prone to saturation. It is difficult to install and maintain infrastructure in and around wetlands. Boundaries of wetlands are fluid over time which may also make trail maintenance more challenging.

Figure 34: Wetlands along the western edge of the Waterworks Parcel

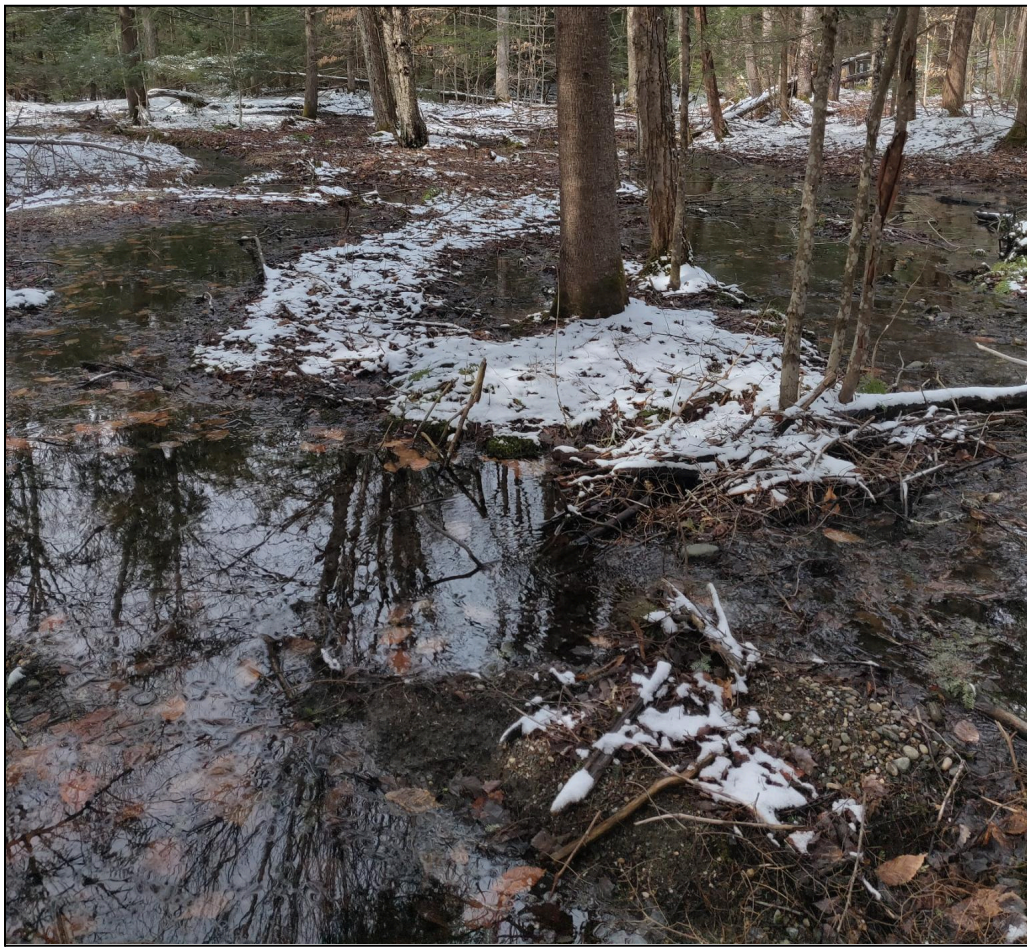
Figure 36: Part of a large wet area not currently mapped as a wetland in ANR Atlas.

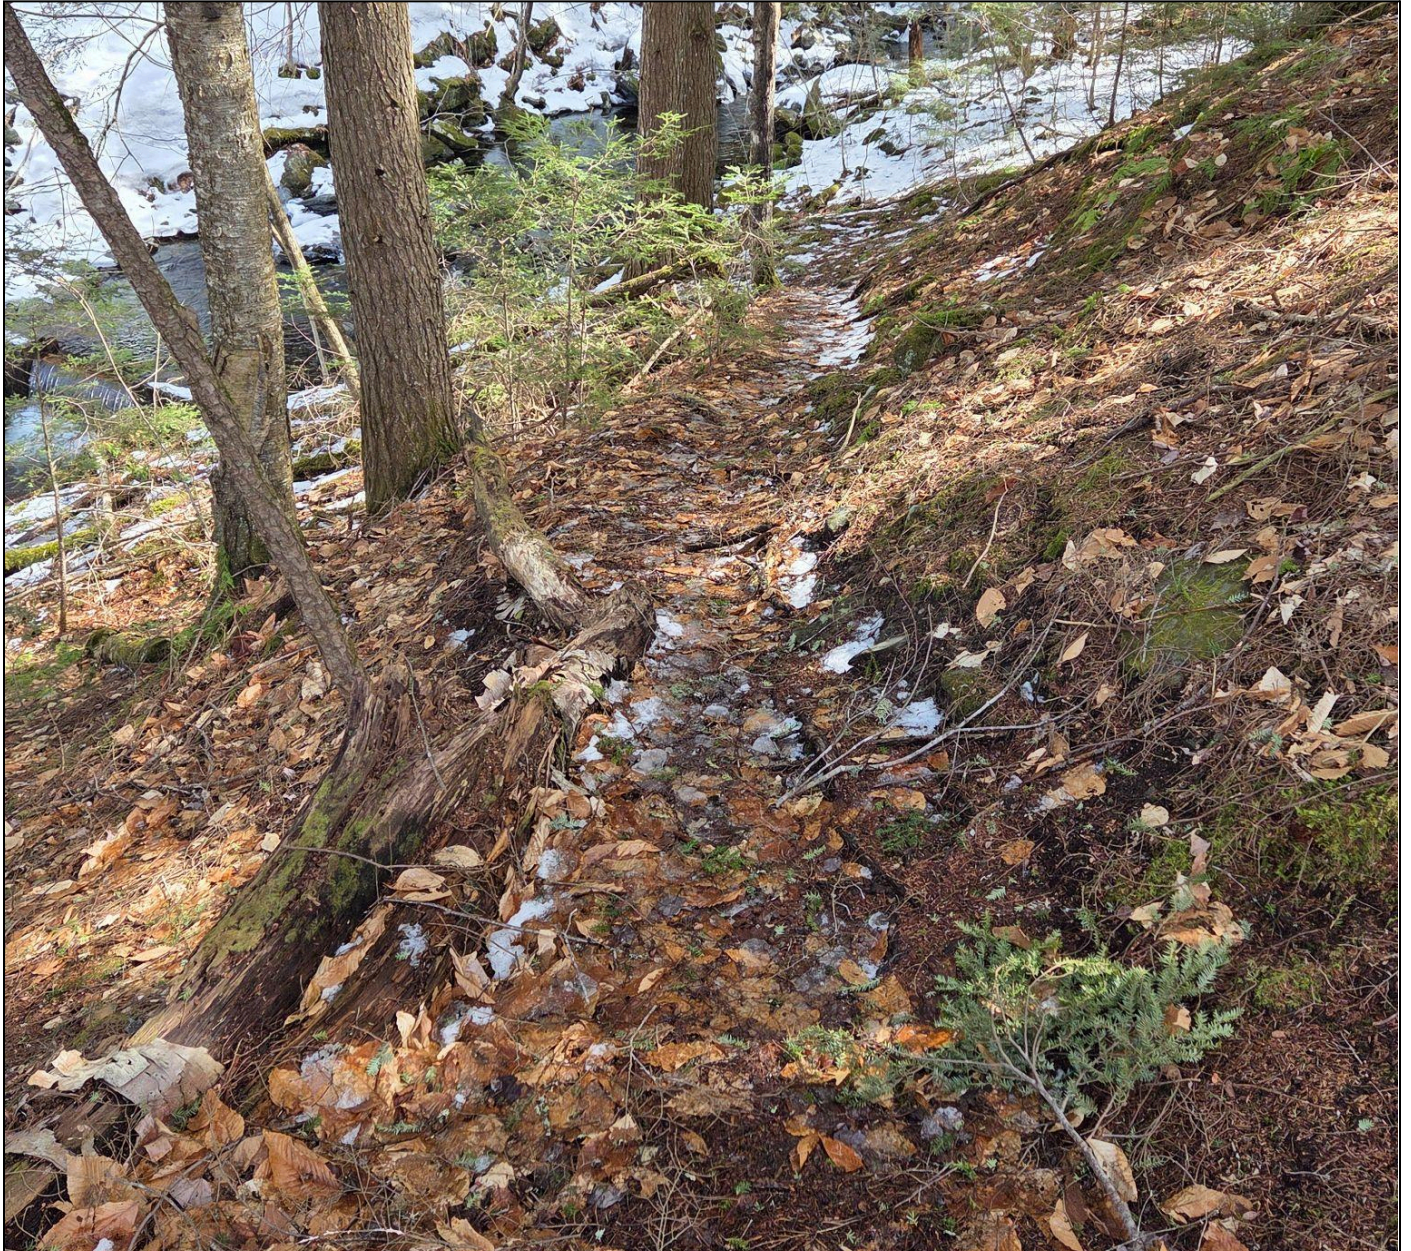
Figure 38: A trail just above Tyler Brook that likely contributes sediment into the stream.

**Any trail or access road (existing or new) will require regular maintenance in order to reduce erosion potential.** If an assessment of the erosion potential of existing trails and roads has not already been conducted, we recommend one in order to determine which sections should be permanently closed and revegetated, and which sections need to stay open but have problem areas that will need ongoing maintenance to prevent further erosion (e.g., clogged drainages, ineffective waterbars). Any trails or roads that are allowed to remain open should have a maintenance plan in place. **If trails are sited, designed, and maintained correctly, we believe that they will have a negligible impact on surface water turbidity.**
