# Edward Farrar Utility District Waterworks Property Landscape Inventory & Assessment

**Spring 2026**

Authors: Lena Andrews, Isaac Buabeng, Clara Chaisson, Gordon Coates,  
Rachelle Klapheke, Summer Lang Moeller, Michelle Lockhart, Lindsey Monteith,  
Annie Nelson, Darian Rubow, Nick Sibley, & Zoë Smiarowski

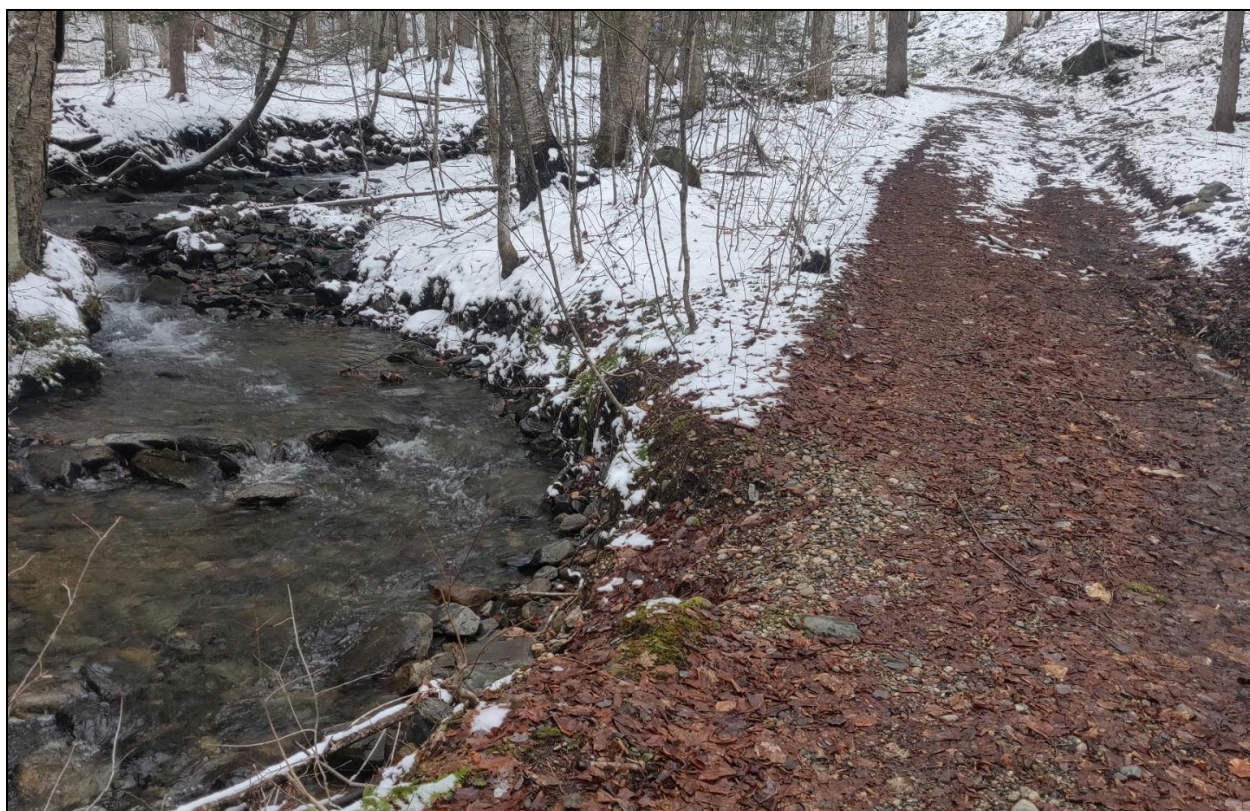
Overall, we noticed more areas of erosion concern along roads (some of which were infrastructure access roads) than along trails, although both were present. Roads can cause more severe erosion because of their larger size and, in some cases, greater tendency to intercept water running downslope. As climate change increases the frequency and severity of heavy rains in New England, erosion challenges on roads and trails are likely to worsen.

Figure 41: An access road eroding into Merriam Brook, near the parking lot (below the dam).

**Any trail or access road (existing or new) will require regular maintenance in order to reduce erosion potential.** If an assessment of the erosion potential of existing trails and roads has not already been conducted, we recommend one in order to determine which sections should be permanently closed and revegetated, and which sections need to stay open but have problem areas that will need ongoing maintenance to prevent further erosion (e.g., clogged drainages, ineffective waterbars). Any trails or roads that are allowed to remain open should have a maintenance plan in place. **If trails are sited, designed, and maintained correctly, we believe that they will have a negligible impact on surface water turbidity.**

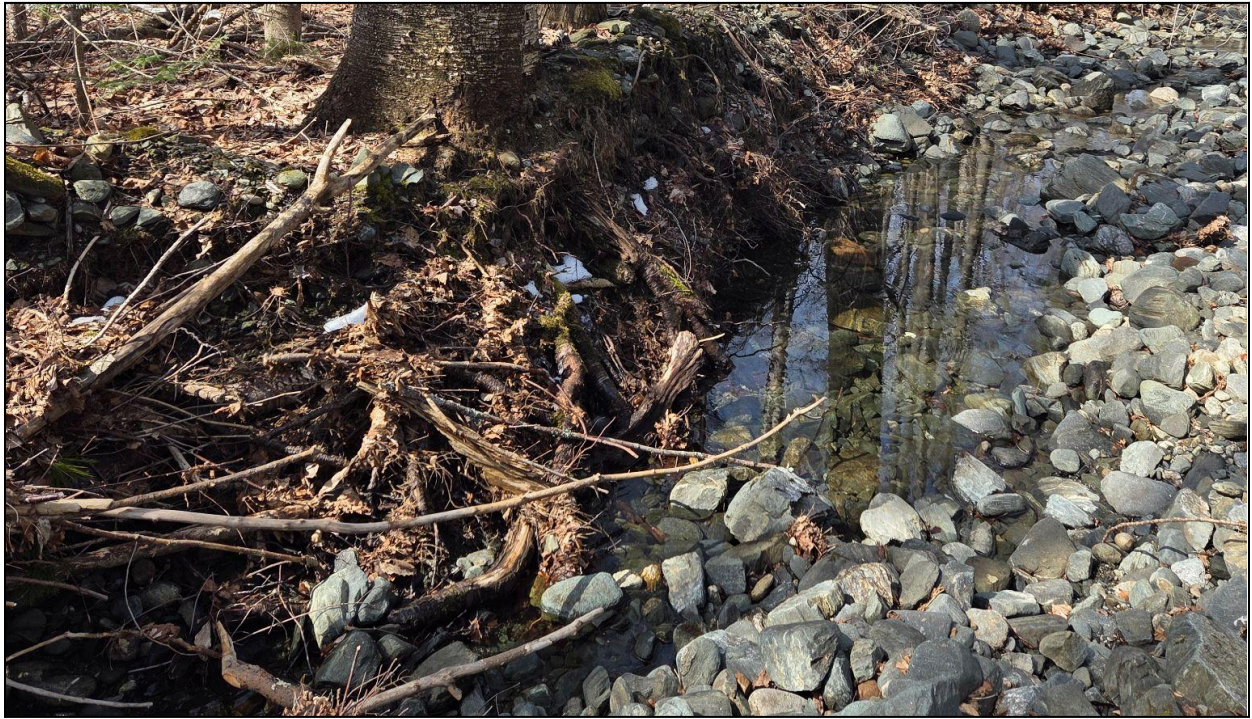
Our on-the-ground assessment showed that even the flatter area, which NRCS labels as having lower erosion potential, has some susceptibility to erosion: we saw clear erosion along some of the stream banks in that zone.

Figure 42: Streambank erosion with exposed tree roots along Tyler Brook just south of Waterworks Road (sandier soil section of parcel).

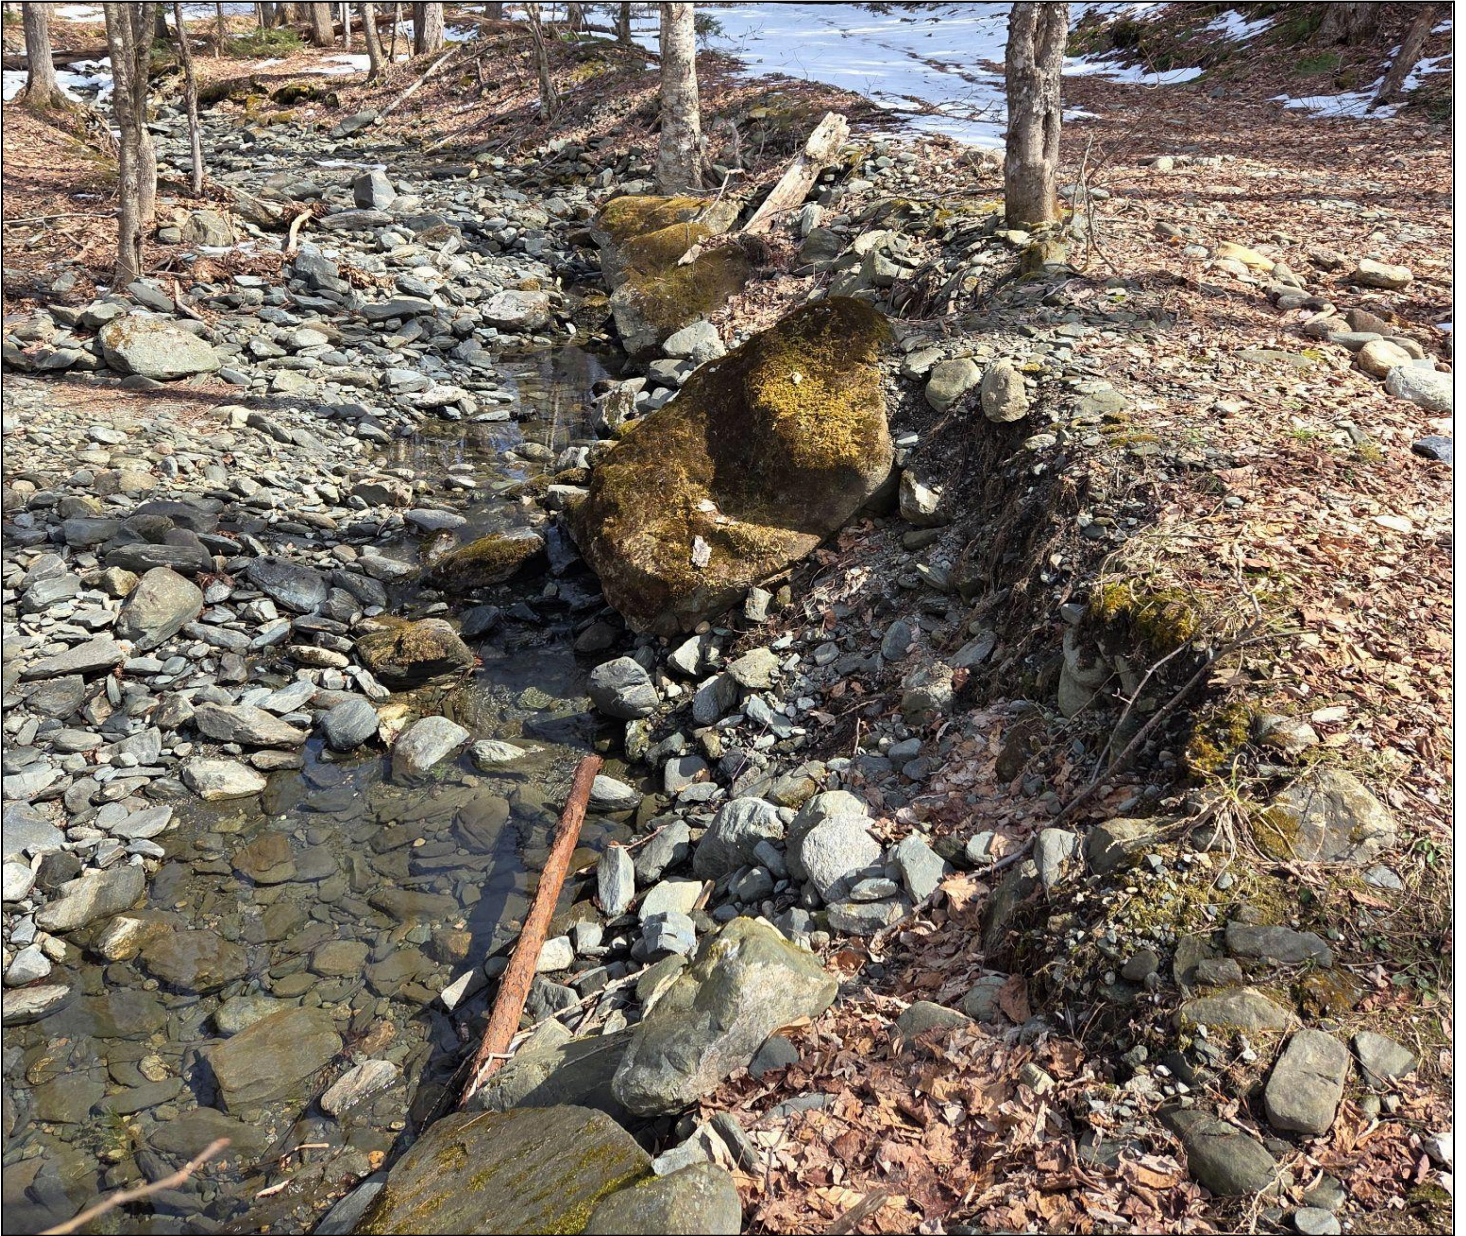
Figure 43: Streambank erosion and road-edge cave-in along Tyler Brook just north of Waterworks Road (sandier soil section of parcel).

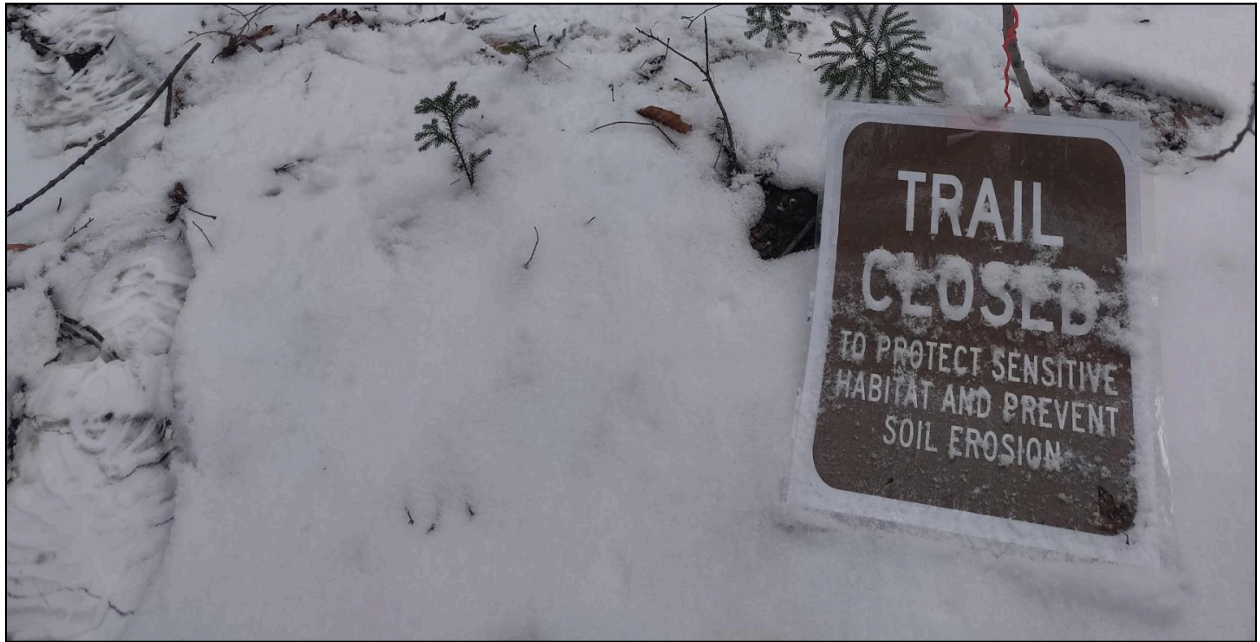
The EFUD Commissioners are concerned about the potential for existing trails to cause soil erosion and more sediment in the surface water supply. Accordingly, they have closed some trails and may choose to keep some or all of these trails closed permanently. If EFUD allows for some trails to remain open or for the construction of new trails in the future (e.g. to reroute problematic sections or replace closed trails), these would need to be strategically designed, sited, and maintained to minimize surface water turbidity, by reducing erosion potential during rains and thaws, especially near streams.

Figure 46: A trail closure sign.

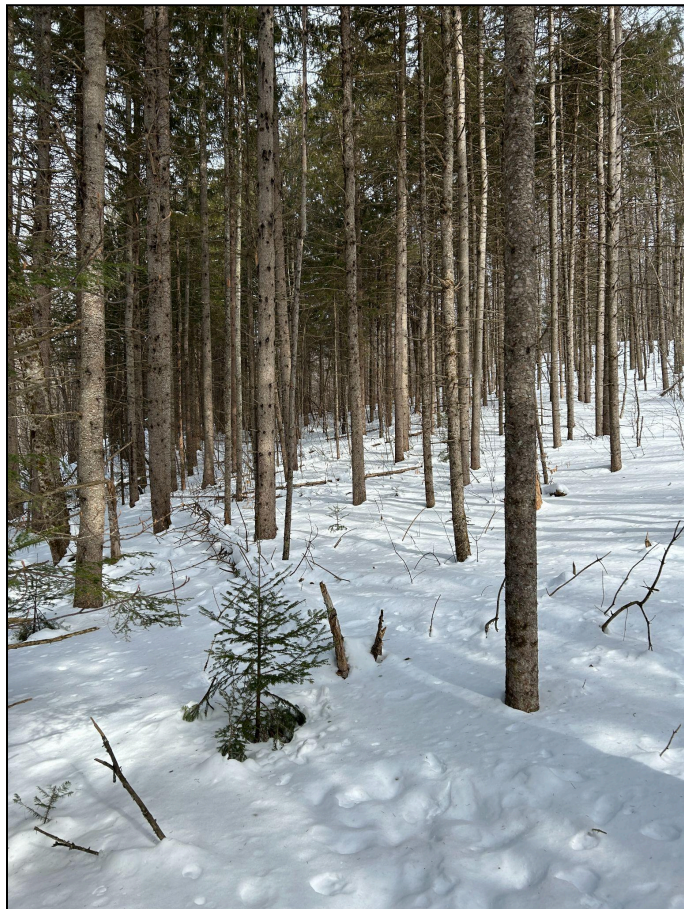
Because forests with low levels of structural diversity can be more susceptible to single, forest-wide disturbance events, uniform trunk diameters, an even distribution of tree heights, and uniform canopies indicate lower levels of resilience. A lack of structural variation means that a single threat, such as a specialized pest or specific wind speed, can impact numerous trees simultaneously, rather than being buffered by a mix of tree sizes, ages and spacing.

Figure 55: Norway Spruce plantation exhibiting low structural diversity.

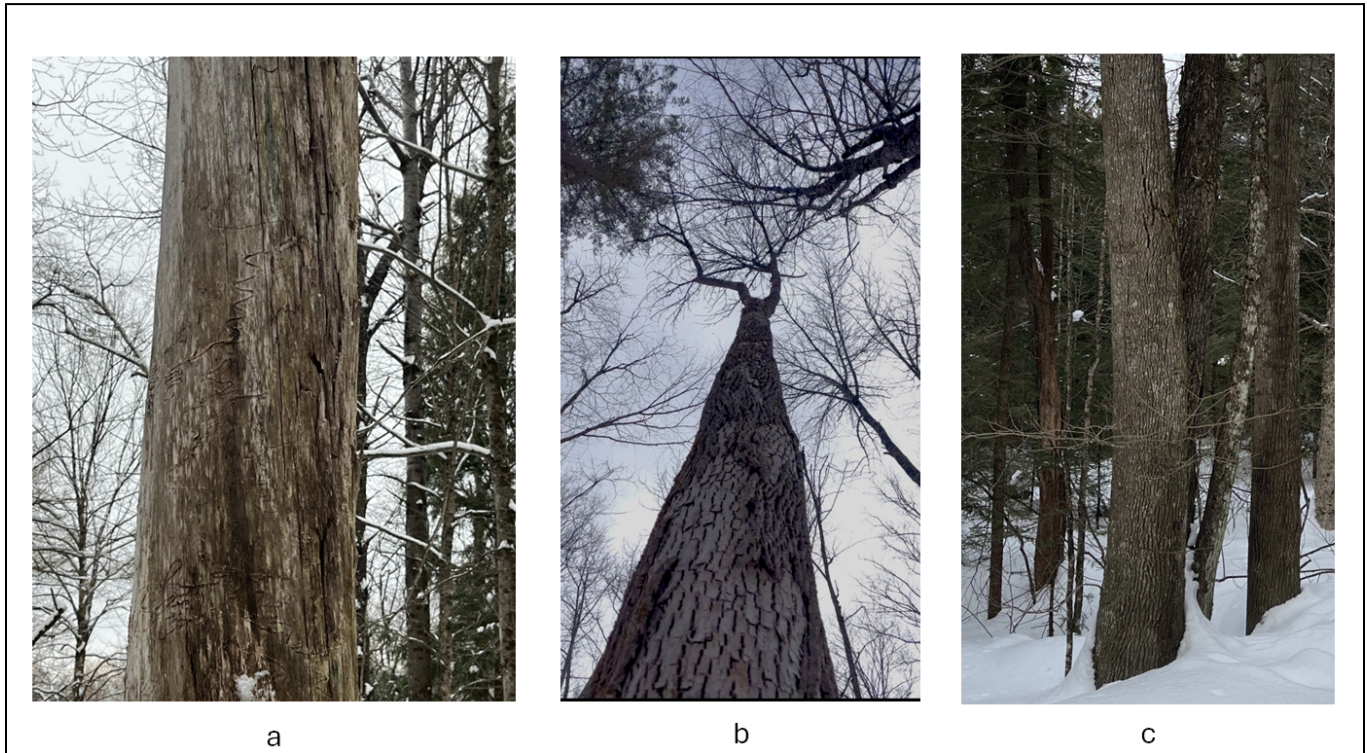
Figure 58: Signs and symptoms of EAB present in the Waterworks parcel: (a) S-shaped beetle galleries on a dead tree, (b) woodpecker flecking causing “blonding” of bark, (c) detached, “sloughing” bark.

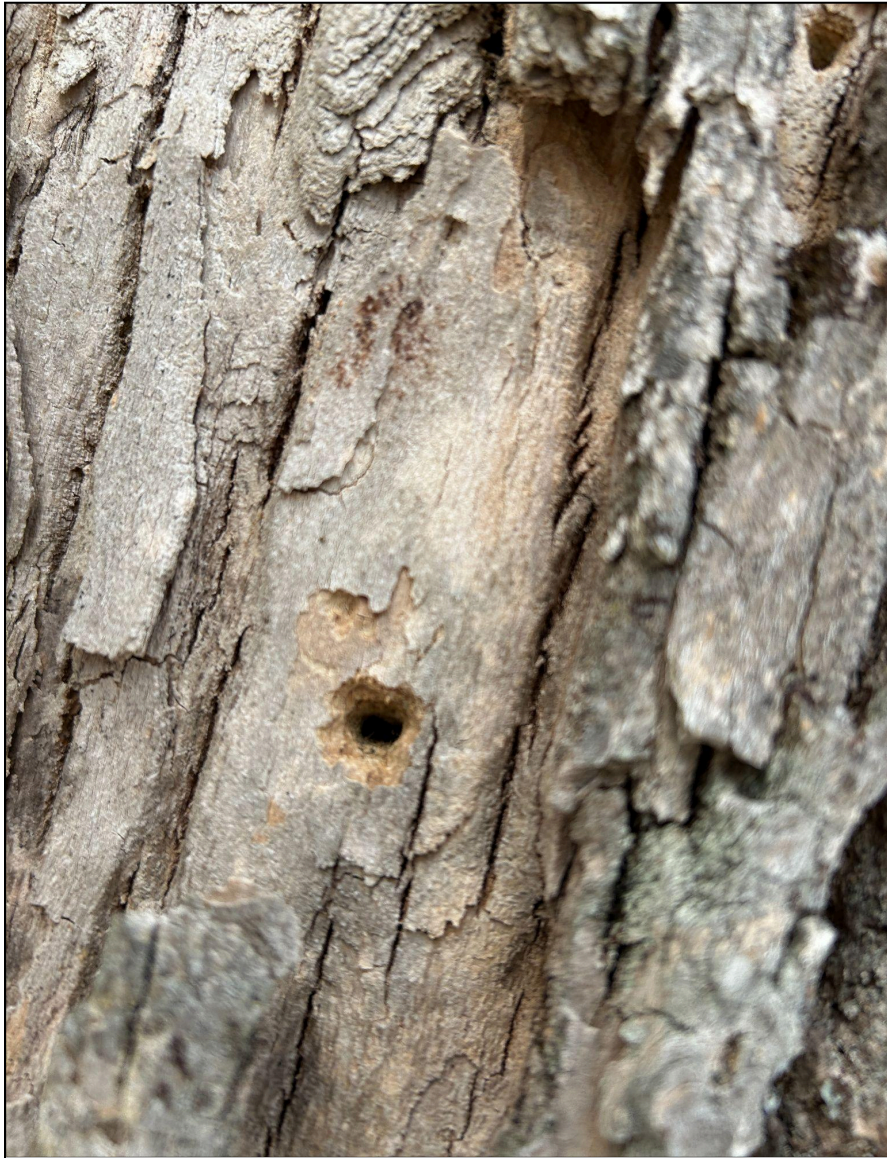
Figure 59: Potential EAB larvae exit holes on a white ash. Note the more recognizable D-shaped exit hole in the upper right corner of the photo.
